RECALL CAMPAIGN BULLETIN

Classification: EL19-054a	Reference: NTB19-097a	Date: December 17, 2019
------------------------------	--------------------------	----------------------------

VOLUNTARY RECALL CAMPAIGN 2018 - 2019 NV200 AND 2019 NV200 TAXI; AV CONTROL UNIT (INFOTAINMENT) SOFTWARE UPDATE

CAMPAIGN ID #: R1911
NHTSA #: 19V-654
APPLIED VEHICLES: 2018 – 2019 NV200 (M20)
2019 NV200 Taxi (M20T)

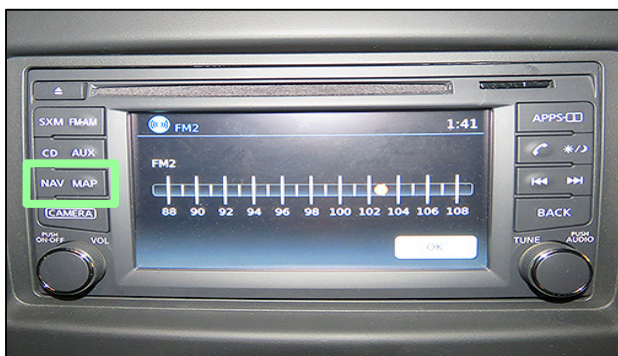
1. Confirm which audio system is present in the vehicle (see Figure 1 and Figure 2 below).
 - If the vehicle is equipped with navigation as shown in Figure 1, below, continue to step 2 below.
 - If the vehicle is **NOT** equipped with navigation, as shown in Figure 2, below, skip to step 19 on page 8.

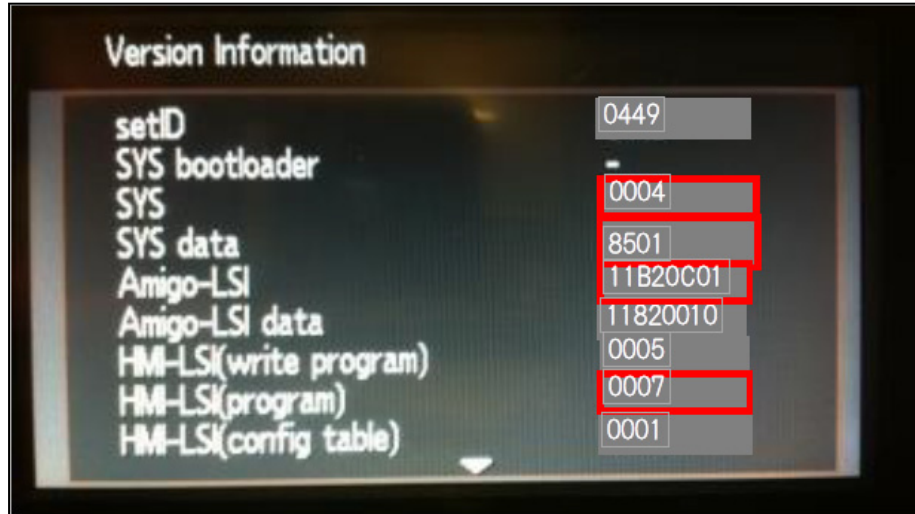
22. Select **Version information**.
23. Compare the highlighted version information with the screen shot shown in Figure 18 below.

- If the version information **Does NOT** match Figure 18 exactly, continue to step 24 for reprogramming of the AV control unit.
 - If the version information matches Figure 18 **EXACTLY**, no repair is needed. Go to **CLAIMS INFORMATION** on the last page. Use claims coding for “Reprogramming Not Needed”.
24. Connect a battery maintainer or smart charger, set to reflash mode or a similar setting.
 25. Set the parking brake.
 26. Turn the ignition ON.
 27. Turn ON the hazard warning lights to prevent the BCM from going into battery saver mode.
 28. Write down the audio settings.
