IMPORTANT SAFETY RECALL

Airstream 19 Ft. Travel Trailer Inverter Recall

NHTSA Recall Number - 19V-655/Transport Canada recall 2019-465

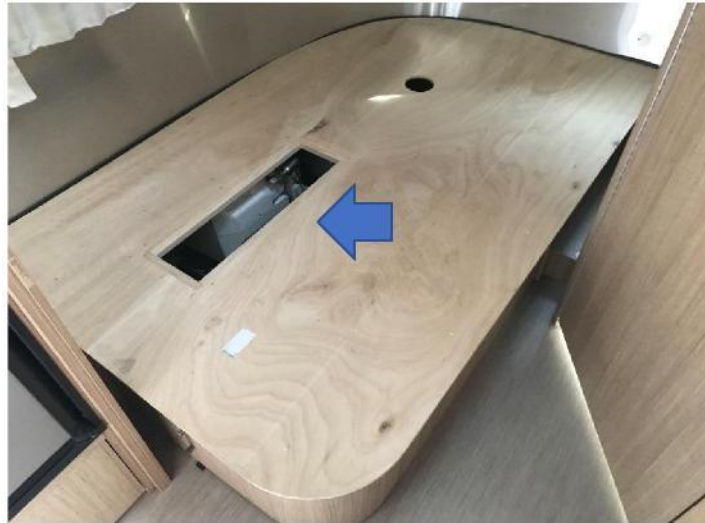
Step 1.

The inverter and inverter fuse holder need to be inspected. Remove the mattress and the removable cover of the bed top. Inspect for the placement of the fuse holder, and verify the plastic cover is present. If the plastic cover is missing it will need to be installed. Please contact Customer Service if a plastic fuse cover is needed. The 100 amp fuse holder and the inverter need to be mounted to the same surface meaning either both mounted to the floor or both mounted to the lower bed frame support.

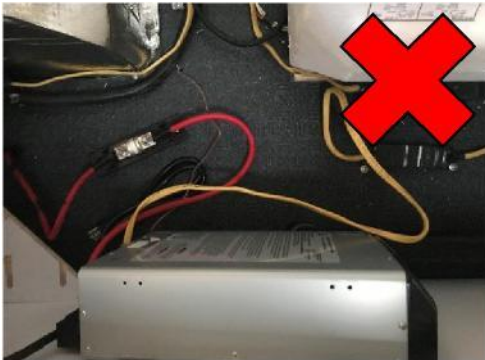
This is incorrect the inverter is on the panel and fuse holder is on the floor.

Inspect inverter fuse holder location and move if it is located on a different surface as the inverter. The Inverter fuse will need to be relocated and secured to the same surface the inverter is located.

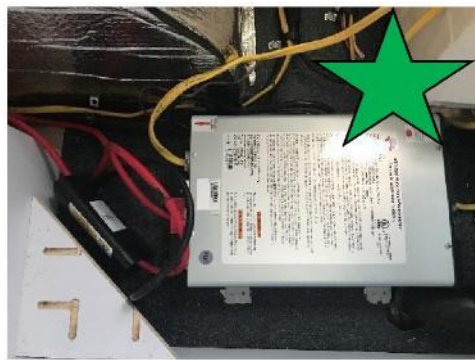
This is correct, the inverter is installed on the floor and the fuse holder is installed on the floor and has the plastic cover installed.

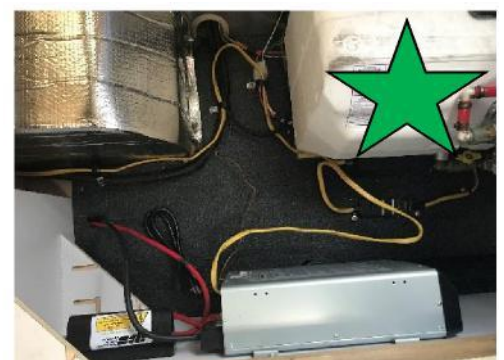
This is correct, the inverter is installed on the panel and the fuse holder is installed on the panel and has the plastic cover installed.
