PRODUCT CAMPAIGN BULLETIN

APPLICABILITY: 2020MY Legacy & Outback

NUMBER: WUL-97

SUBJECT: Brake Pedal Bracket Mounting Bolt Inspection

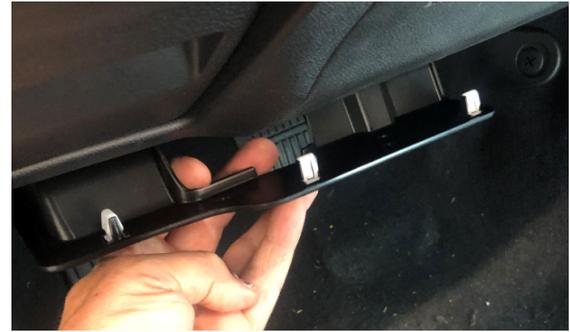
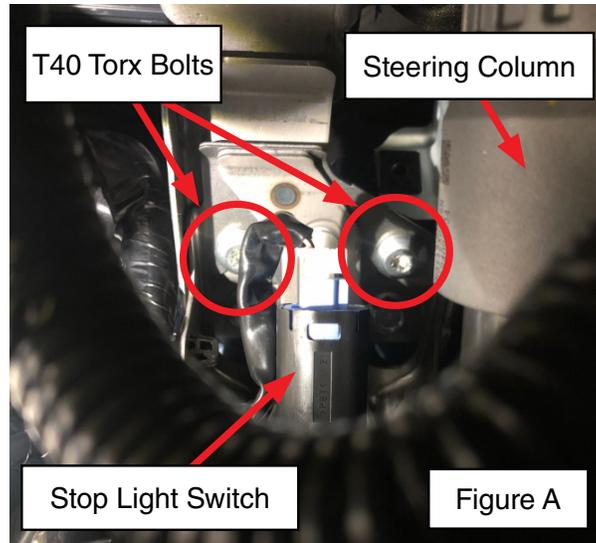
IMPORTANT NOTE: The picture (**Figure A**) below shows the mounting bolt area of the brake pedal assembly with the lower dash under-cover removed. When performing this initial inspection, **only** the bottom cover shown above needs to be removed.

There are 2 bolts used to secure the front (closest to the driver) portion of the brake pedal assembly to the mounting bracket. The T-40 Torx bolts are secured with a 12 mm flanged hex nut.

- Assemble the torque wrench, necessary extension(s) and the T40 Torx bit. If the torque wrench is digital, Set it to 5 Nm (3.7 ft. lbs. or 15 inch-pounds).
- Confirm both T40 Torx bolts are present as shown in **Figure A** above.
- Check the bolt torque while paying close attention for any movement (using a clockwise/ tightening motion) of the bolt prior to the specified value being reached. **NOTE:** The plastic foot ventilation duct can be easily moved backward enough to gain sufficient access to check the bolt torque

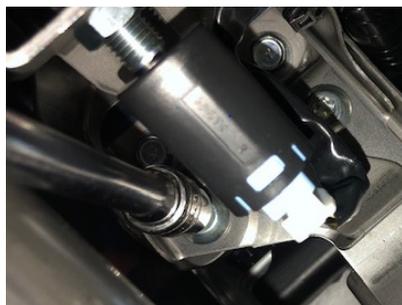
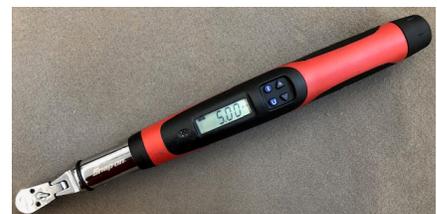
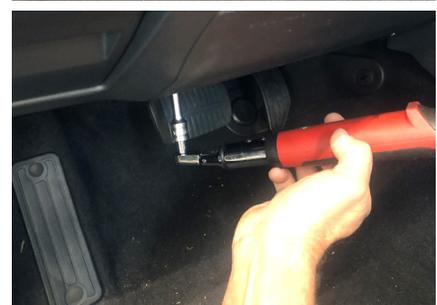
IMPORTANT NOTE: Use caution to not move the duct any more than necessary. If it becomes loose, it must be replaced as it is a **one-time use** part.
