PRODUCT CAMPAIGN BULLETIN

APPLICABILITY: 2020MY Legacy & Outback **NUMBER:** WUL-97R
SUBJECT: Brake Pedal Bracket Mounting Bolt Inspection **DATE:** 09/11/19
REVISED: 09/27/19
NHTSA ID: 19V664

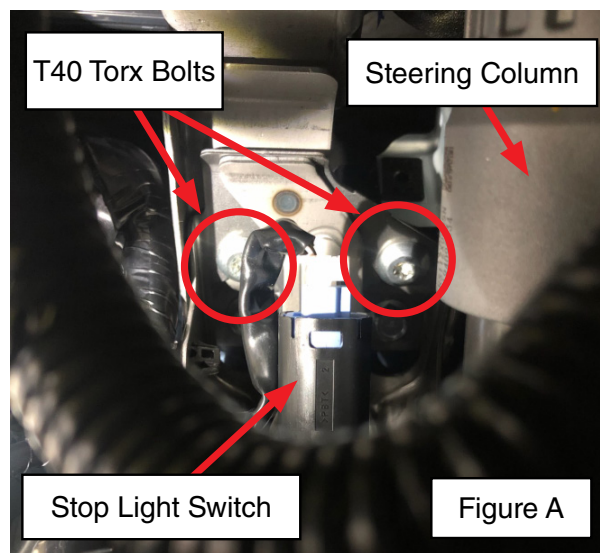
IMPORTANT NOTE: The picture (**Figure A**) below shows the mounting bolt area of the brake pedal assembly with the lower dash under-cover removed. When performing this initial inspection, **only** the bottom cover shown above needs to be removed.

There are 2 bolts used to secure the front (closest to the driver) portion of the brake pedal assembly to the mounting bracket. The T-40 Torx bolts are secured with a 12 mm flanged hex nut.

- Assemble the torque wrench, necessary extension(s) and the T40 Torx bit. If the torque wrench is digital, Set it to 5 Nm (3.7 ft. lbs. or 44.3 inch-pounds).
- Confirm both T40 Torx bolts are present as shown in **Figure A** above.
- Check the bolt torque while paying close attention for any movement (using a clockwise/ tightening motion) of the bolt prior to the specified value being reached. **NOTE:** The plastic foot ventilation duct can be easily moved backward enough to gain sufficient access to check the bolt torque

- If **BOTH** bolts are present and hold the torque **WITHOUT TURNING** when checking, the vehicle is **OK**. Reinstall the lower dash under cover panel and proceed to the Claim Reimbursement and Entry Procedures section.
- If **EITHER** of the bolts are missing **OR** turn **AT ALL** when checking the torque, this is a **NG** test result and will be **EXTREMELY RARE**. Proceed with replacing the brake pedal assembly following the procedure in the applicable Service Manual.

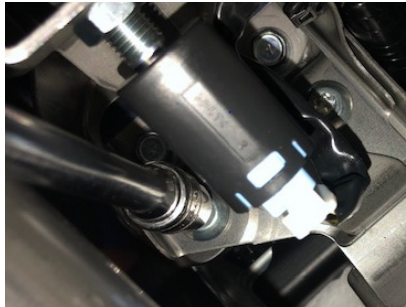
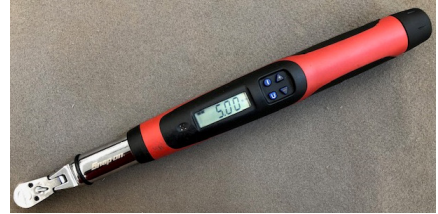
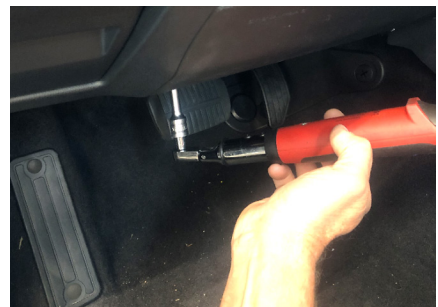
Use caution to not move the duct any more than necessary. If it becomes loose, it must be replaced as it is a **one-time use** part.

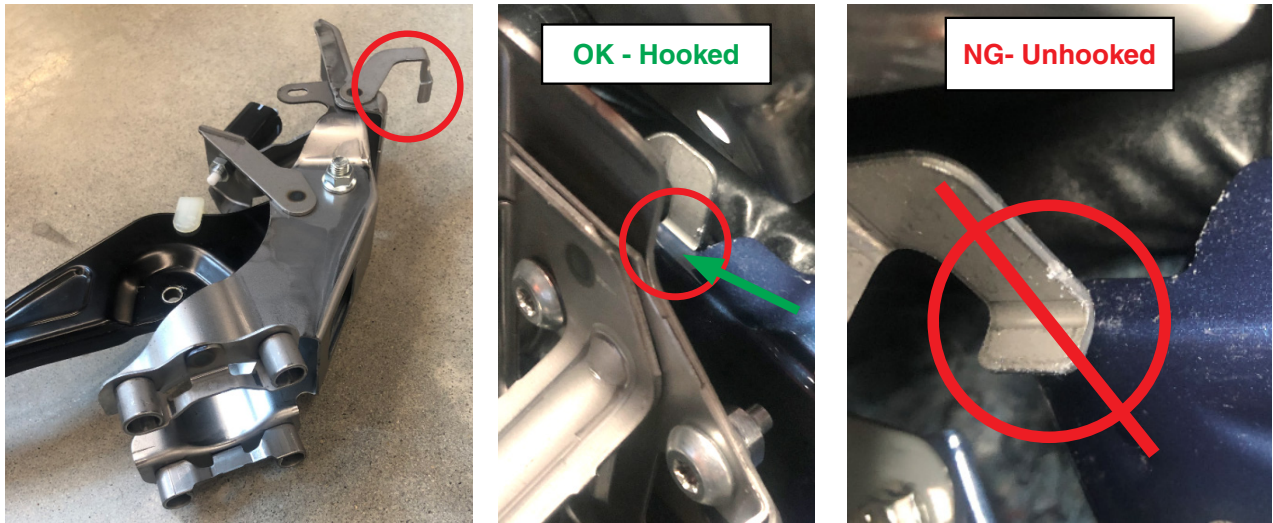
5. When installing the new brake pedal assembly, there is a tab portion which must be “hooked” onto a body-colored bracket to help hold it in place during assembly. The photo sequence below shows the tab portion and **OK** and **NG** photos for comparison to help confirm proper installation.
