## PRODUCT CAMPAIGN BULLETIN

**APPLICABILITY:** 2020MY Legacy & Outback

**NUMBER:** WUL-97R

**SUBJECT:** Brake Pedal Bracket Mounting Bolt Inspection

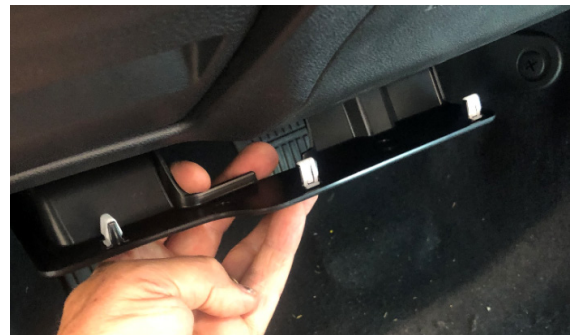
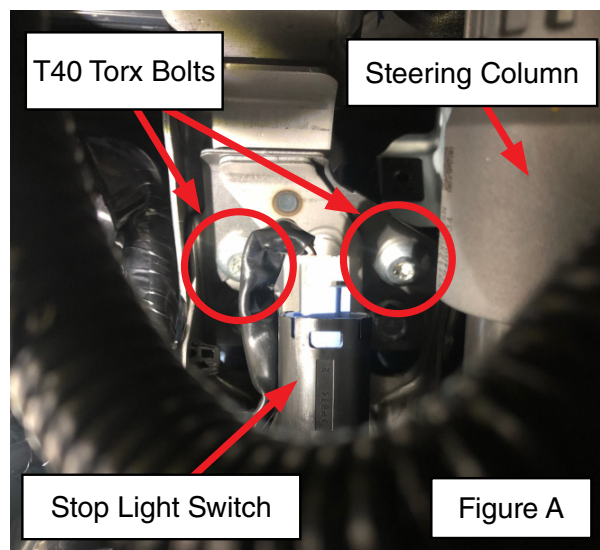
**IMPORTANT NOTE:** The picture (**Figure A**) below shows the mounting bolt area of the brake pedal assembly with the lower dash under-cover removed. When performing this initial inspection, **only** the bottom cover shown above needs to be removed.

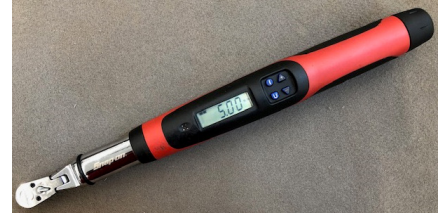
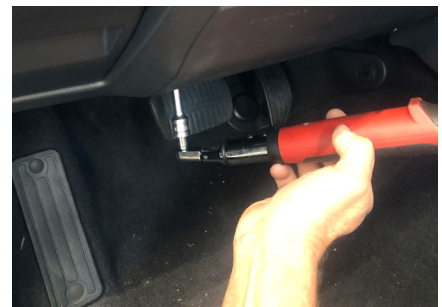
- Assemble the torque wrench, necessary extension(s) and the T40 Torx bit. If the torque wrench is digital, Set it to 5 Nm (3.7 ft. lbs. or 44.3 inch-pounds).
- Confirm both T40 Torx bolts are present as shown in **Figure A** above.
- Check the bolt torque while paying close attention for any movement (using a clockwise/ tightening motion) of the bolt prior to the specified value being reached. **NOTE:** The plastic foot ventilation duct can be easily moved backward enough to gain sufficient access to check the bolt torque

Use caution to not move the duct any more than necessary. If it becomes loose, it must be replaced as it is a **one-time use** part.

- If **BOTH** bolts are present and hold the torque **WITHOUT TURNING** when checking, the vehicle is **OK**. Reinstall the lower dash under cover panel and proceed to the Claim Reimbursement and Entry Procedures section.
- If **EITHER** of the bolts are missing **OR** turn **AT ALL** when checking the torque, this is a **NG** test result and will be **EXTREMELY RARE**. Proceed with replacing the brake pedal assembly following the procedure in the applicable Service Manual.
