TO: Freightliner Dealer Principals, General Managers, Sales Managers, Service Managers, Parts Managers	FROM: Anthony Washington, Department Manager, Regulations and Certifications
RE: Recall Campaign Notification Model 907 (Sprinter) Model Years 2019 Screw Connection Hood Catch	DATE: October 17, 2019

Campaign No. :	Campaign Desc. :	Screw Connection Hood Catch
2019100006	VS3HAUBOSS	
<p>This is to notify you of the upcoming Recall Campaign concerning the screw connection on the upper hood catch on approximately 3,817 MY19 Mercedes-Benz Sprinter vans. The recall campaign will be visible on the www.safercar.gov website and may generate questions from customers. All affected VINs will be flagged as "Open" in VMI on October 18, 2019.</p>		
Background		
Issue	Daimler AG ("DAG"), the manufacturer of Freightliner Sprinter vans, has determined that, the screw connection on the upper hood catch of certain Freightliner Sprinter vehicles (VS30; Platforms 907) may not have been carried out according to specification. Depending on vehicle speed, wind resistance, aerodynamic drag and factors such as vehicle loading and road conditions, the hood could open while the vehicle is being operated. If t

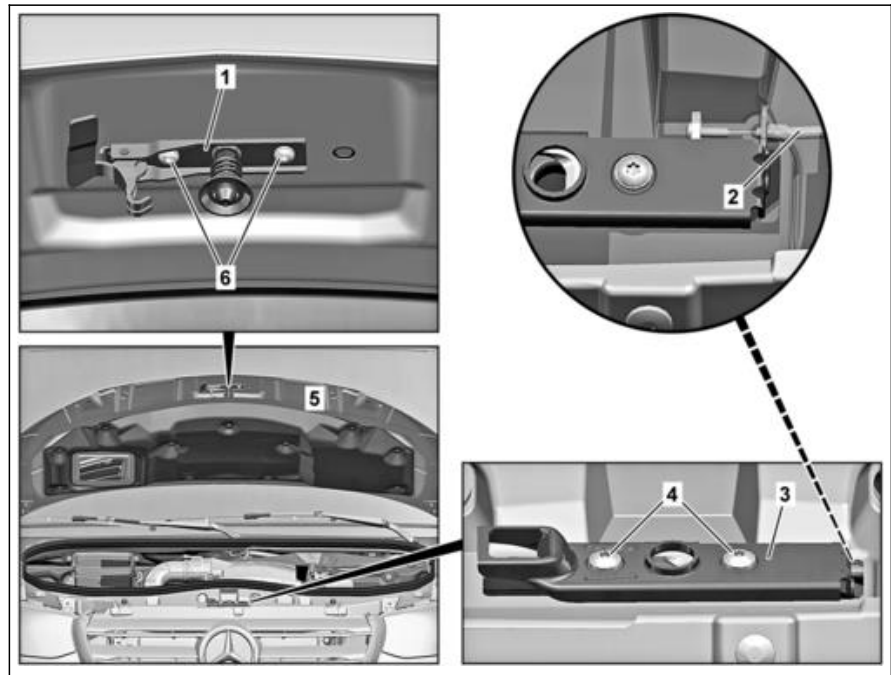
D88.40-1130-06

Daimler AG ("DAG"), the manufacturer of Freightliner Sprinter vans, has determined that, the screw connection on the upper hood catch of certain Freightliner Sprinter vehicles (VS30; Platforms 907) may not have been carried out according to specification. Depending on vehicle speed, wind resistance, aerodynamic drag and factors such as vehicle loading and road conditions, the hood could open while the vehicle is being operated. If the hood were to open while driving, it could impact the driver's field of vision, thereby increasing the risk of a crash. An authorized Freightliner Sprinter dealer will check and if necessary tighten the torque of the screw connection. Any missing screws will be replaced if necessary.

- 1 Hood catch upper section
6 Bolts

2	Check whether the screws (6) are present.	If a screw (6) are not present, ↓ screw in missing screw (6) subsequently by hand.	
Retighten Screws			
3	Retighten screws (6).	Bolt, upper section of hood catch to hood	BA88.40-N-1003-01TS

Number	Designation	Model 907
BA88.40-N-1003-01TS	Bolt, upper section of hood catch	8Nm
