PRODUCT CAMPAIGN BULLETIN

APPLICABILITY: 2015-18MY Forester **NUMBER:** WUM-98R
SUBJECT: Occupant Detection Wiring Harness Inspection **NHTSA ID:** 19V-701
DATE: 10/14/19
REVISED: 11/20/19

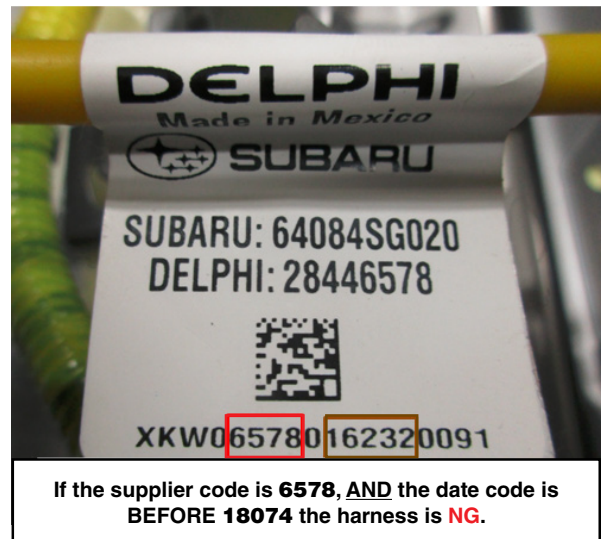
Step 1. If the date code (**BROWN** box in photo) on the label is **AFTER 18074**, the harness is **OK**. See additional ****NOTE** below.

Step 2. If the date code is **18074** or **BEFORE AND** has the supplier code **6578** (**RED** box in photo) on it, the harness is **NG** and the seat cushion assembly must be replaced. Always order the most up-to-date part number seat cushion assembly for the VIN being repaired. Follow the Service Procedure in the applicable Service Manual for the repair.

- “16” is the year (2016) and “232” is the 232nd day of the year: “16232”.

IMPORTANT: The Repair Order must include the Original **AND** (if the seat bottom assembly was replaced) the replacement part’s supplier code and date information as outlined above. Use the following example: **6578-18074**.
