PRODUCT CAMPAIGN BULLETIN

APPLICABILITY: 2015-18MY Forester **NUMBER:** WUM-98R
SUBJECT: Occupant Detection Wiring Harness Inspection **NHTSA ID:** 19V-701
DATE: 10/14/19
REVISED: 10/28/19

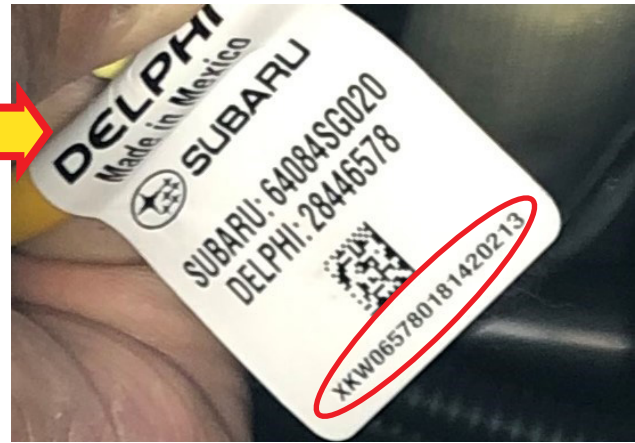
INSPECTION:

- There is enough room under the seat to access the harness label and perform the date / supplier code inspection without removing the seat assembly.
- Do not pull on the sensor mat harness with excessive force. There is enough flexibility and slack in the harness available to access the label for this inspection.

Step 1. If the date code (**BROWN** box in photo) on the label is **AFTER 18074**, the harness is **OK**. See additional ****NOTE** below.

Step 2. If the date code is **18074** or **BEFORE AND** has the supplier code **6578** (**RED** box in photo) on it, the harness is **NG** and the seat cushion assembly must be replaced. Always order the most up-to-date part number seat cushion assembly for the VIN being repaired. Follow the Service Procedure in the applicable Service Manual for the repair.

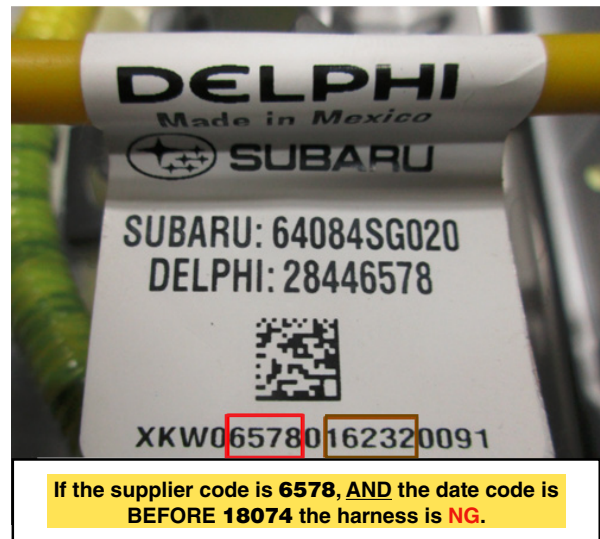
- “16” is the year (2016) and “232” is the 232nd day of the year: “16232”.

IMPORTANT: The Repair Order must include the Original **AND** (if the seat bottom assembly was replaced) the replacement part's supplier code and date information as outlined above. Use the following example: **6578-18074**.
