PRODUCT CAMPAIGN BULLETIN

APPLICABILITY: 2015-18MY Forester **NUMBER:** WUM-98R
SUBJECT: Occupant Detection Wiring Harness Inspection **NHTSA ID:** 19V-701
DATE: 10/14/19
REVISED: 02/07/20

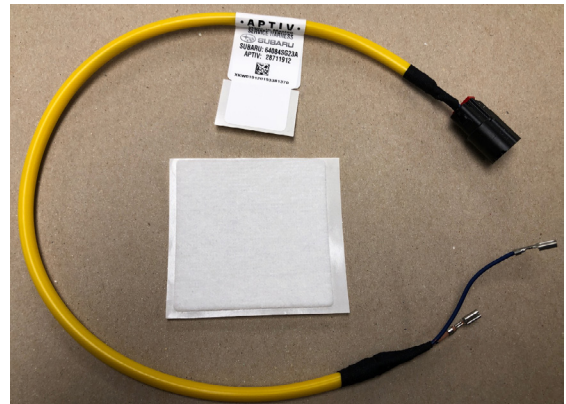
A. (PREFERRED METHOD) Replace the pictured ODS harness (p.n. **64084SG23A**) following the Harness Replacement Procedure below

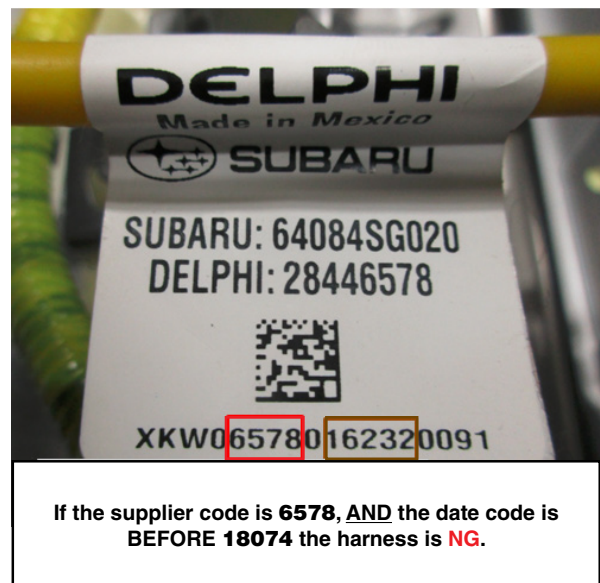
Step 1. If the date code (**BROWN** box in photo) on the label is **AFTER 18074**, the harness is **OK**. Harness replacement is **NOT** necessary. See additional ****NOTE** below.

Step 2. If the date code is **18074** or **BEFORE AND** has the supplier code **6578** (**RED** box in photo) on it, the harness is **NG** must be replaced. Proceed to Harness Replacement Procedure as outlined below.

- “16” is the year (2016) and “232” is the 232nd day of the year: “16232”.
