R19AH

Subject: RECALL R19AH – Joint Strength Noncompliance – Insufficient Roof Rivet Quantity

NHTSA Recall Number: 19V-707 School Bus

R19AH – Insufficient Roof Rivet Quantity

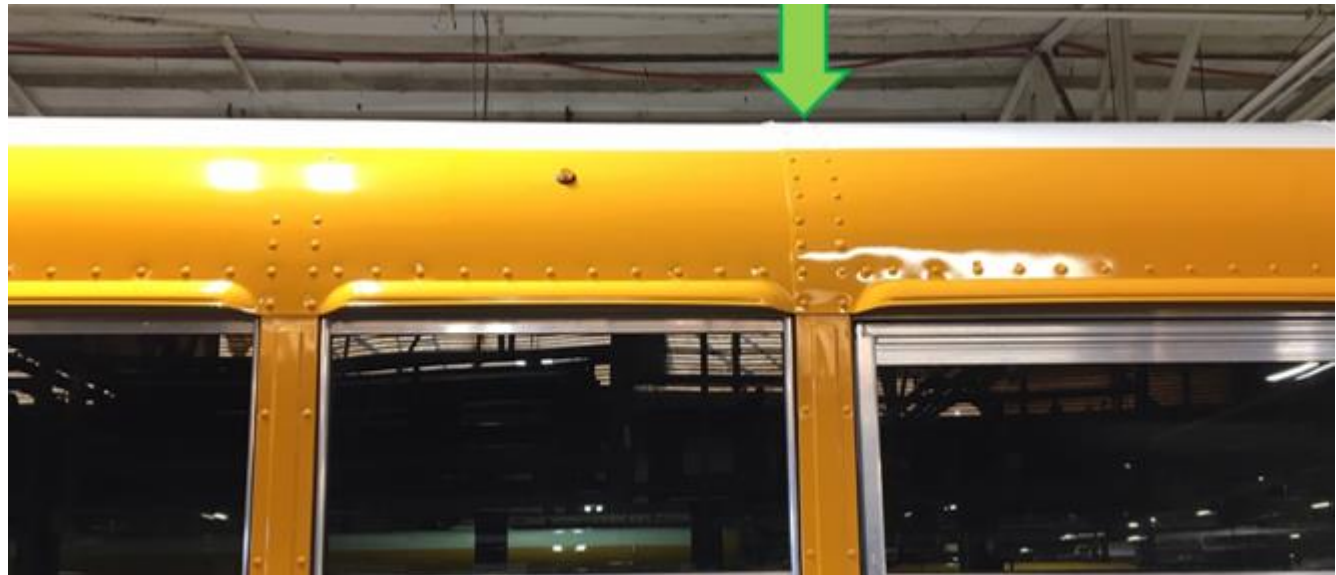
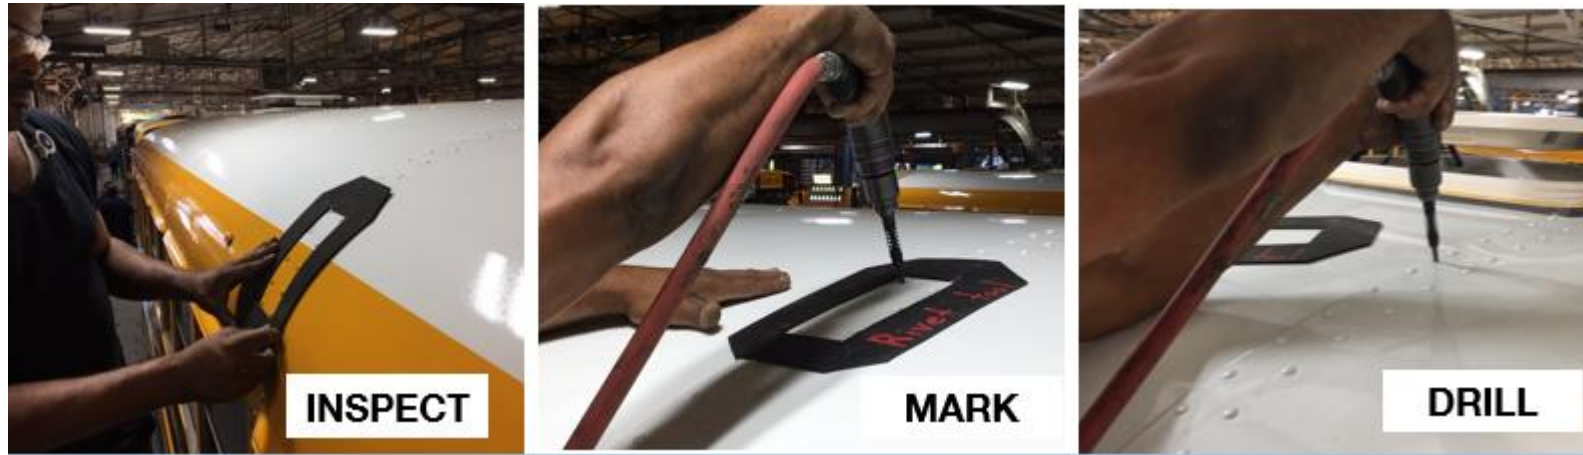
Issue: On certain units, the roof sheet rivet spacing may be incorrect in some segments, resulting in noncompliance with FMVSS 221, School Bus Body Joint Strength.

3. Inspect rivet spacing at each roof sheet joint. Roof sheet joints are assembled with two rows of rivets. Joint must have a minimum of six rivets in an eight inch segment. The full length of the roof sheet joint, including the top of the bus, must be inspected and corrected, if needed.

- a. Place the supplied rivet spacing template over the joint and parallel to the edge of the roof sheet, allowing roof rivets to be exposed through the opening in the template, as shown.

- b. Move the template from one side of the roof sheet towards the center of the roof.
 - c. If a segment in the roof joint contains less than six rivets, additional rivets are required. Mark each area that requires additional rivets.

- d. If one rivet is required; add a rivet equally spaced between the two rivets with the largest space in this section.
 - e. If additional rivets are required; add additional rivets between the largest spaces until a minimum of six (6) rivets have been added in the eight (8) inch segment.

4. Using a short 17/64" drill bit, drill a hole through the roof sheet and bow flange only. **Be sure not to drill through the inside headliner.** Drill any required holes on a common centerline with existing rivets.

5. Install rivet (Item 1) in each drilled hole.
6. With the correct color paint, touch up each blind rivet installed.
7. Repeat procedure on the opposite side of the bus.
