TO: Mercedes-Benz Dealer Principals, General Managers, Sales Managers, Service Managers, Parts Managers	FROM: Anthony Washington, Department Manager, Regulations and Certifications
RE: Recall Campaign Notification Model 447 (Metris) Model Years 2016 - 2020 Seat Base Cover	DATE: February 20, 2020

Campaign No. 2020010011, February 2020

SUBJECT: **Model 447 (Metris), Model Year 2016 - 2020**
Seat Base Cover

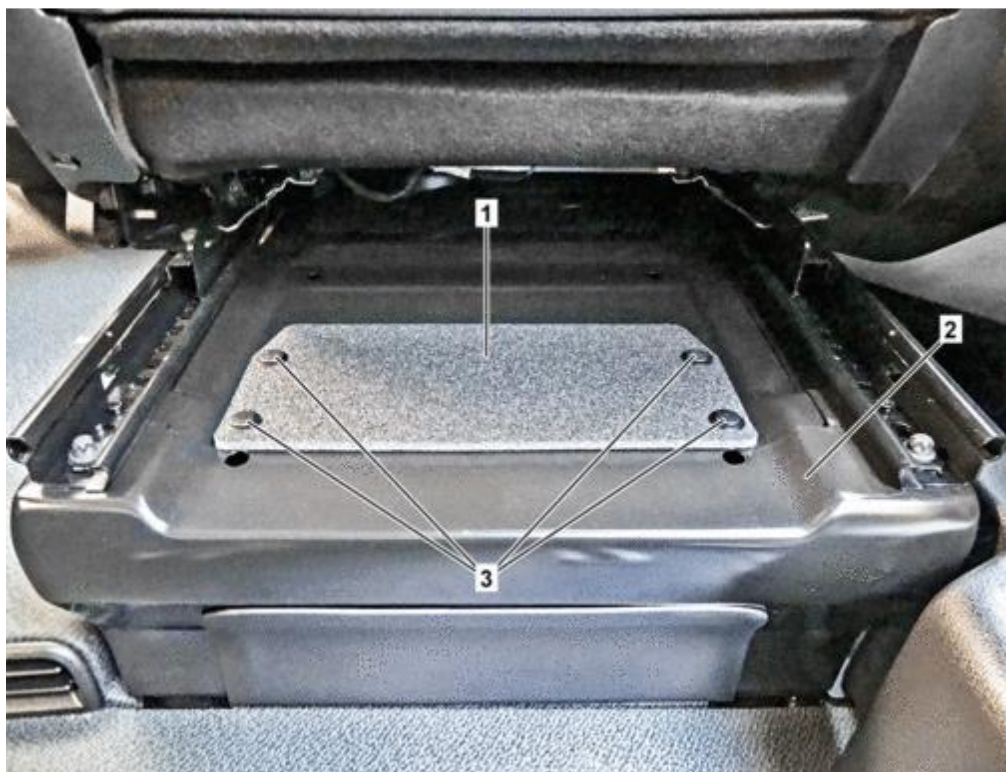
S91.10-A006-76

Mercedes-Benz AG (“MBAG”), the manufacturer of Mercedes-Benz vehicles, has determined that certain Mercedes-Benz Metris vehicles (platform 447 (VS20)) with an integrated backup battery located beneath the front passenger’s seat box were produced without a seat base cover. Without a seat base cover, the opening in which the integrated backup battery is located can be exposed when the seat is moved forward. An object containing conductive material, such as metal, could be unintentionally dropped into the opening and make contact with the poles on the battery. Were such contact to occur, a short circuit could result, increasing the risk of a fire. An authorized Mercedes-Benz dealer will retrofit and install the seat base cover in the potentially affected vehicles.

- 1 Top cover
- 2 Right front seat mounting support
- 3 Expansion rivet

2	Install top cover (1) onto right front seat mounting support (2).	<p>Before installation of the top cover (1), check the right front seat mounting support (2) for any inserted foreign objects. The right front seat mounting support (2) must not be used as the stowage compartment or stowage space. Otherwise, inserted foreign objects may cause damage to the electrical system.</p> <p>

To do so, adjust right front seat forward and upward (see operator's manual). Install top cover (1) with 4 expansion rivets (3) onto right front seat mounting support (2).</p>	
---	---	--	--
