PRODUCT CAMPAIGN BULLETIN

APPLICABILITY: 2017-19MY Impreza
2018-19MY Crosstrek

NUMBER: WUQ-02R

SUBJECT: Ignition Coil Short Circuit

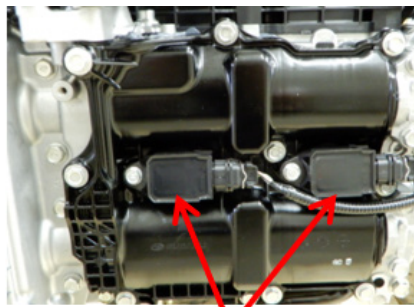
OK

Step 4: Inspect all 4 ignition coils CLOSELY for any damage, cracking, fissures, etc. **Coil removal is NOT necessary as any damage will be external.** Were any cracks, fissures or other damage found on any of the 4 ignition coils?

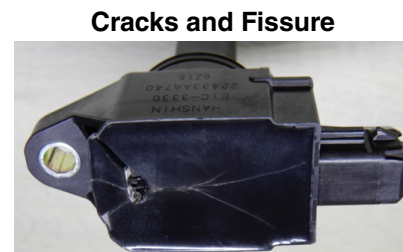
NG

Cracks and Fissure

YES: Replace any damaged coil(s) (rare case) following the procedure in the applicable Service Manual then proceed to **Step 5** and using the SSM, check for any stored DTCs.
