SUBJECT: NEW VEHICLE DEMONSTRATION / DELIVERY HOLD - Safety Recall 19S38
– Supplement #2
 Certain 2015-2017 Transit Vehicles
 Driveshaft Flexible Coupling

NEW VEHICLE DEMONSTRATION / DELIVERY HOLD - Safety Recall 19S38 - Supplement #2

CERTAIN 2015-2017 TRANSIT VEHICLES EQUIPPED WITH A DRIVESHAFT FLEXIBLE COUPLING — DRIVESHAFT FLEXIBLE COUPLING REPAIR

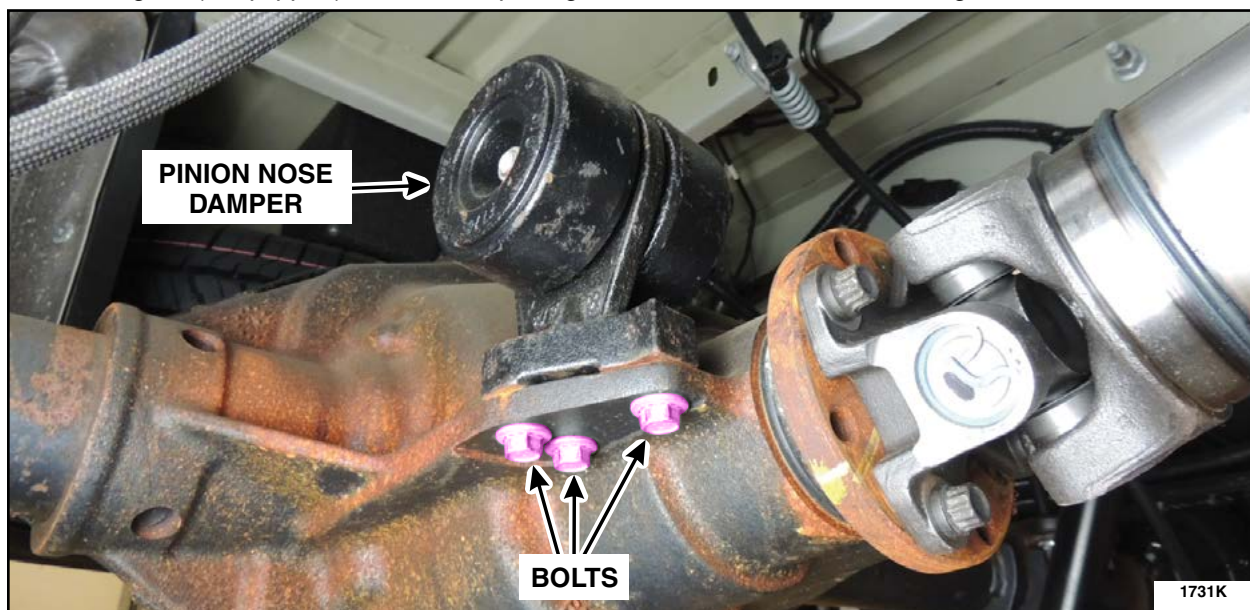
FIGURE 24

NOTE: Original pinion nose damper is shown. *New* pinion nose damper may appear similar to the original (if equipped), but the dampening characteristics have been changed.

1. If a pinion nose damper is present, remove and discard the three bolts and the original pinion nose damper located on the RH side of the rear axle center housing. See Figure 24.
2. Install a *new* pinion nose damper and tighten the three bolts. See Figure 24.
 - Tighten bolts to 46 lb.ft (62 Nm).
