November 2019  
FL835A  
NHTSA #19V-769  
Transport Canada #2019-539

## Subject: Western Star 4700 Steering Pinch Bolts

**Models Affected: Specific Model Year 2020 Western Star 4700 model vehicles manufactured January 7, 2019, through October 4, 2019, at the Cleveland Truck Manufacturing Plant.**

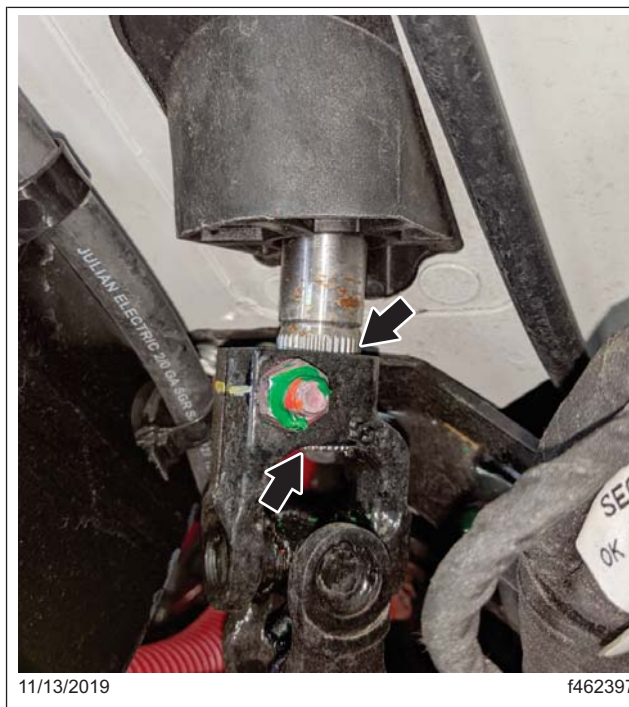
**Fig. 1, Stub Shaft Splines**

1. Check the base label (Form WAR259) for a completion sticker for FL835 (Form WAR260) indicating this work has been completed. The base label is usually located on the passenger-side door, about 12 inches (30 cm) below the door latch. If a completion sticker is present, no work is needed. If a completion sticker is not present, proceed to the next step.
2. Park the vehicle on a level surface, shut down the engine, apply the parking brakes, and chock the tires.
3. Open the hood, and locate the yoked steering shaft connection near the fire wall. See **MOD 538**.
4. Inspect the connection where the steering shaft yoke connects to the splined end of the stub-shaft as shown in **Fig. 1**.

If splines are correctly inserted and visible on both sides of the connection as indicated by the arrows, **NO replacement parts** are required. Go to step 6.

If the splines are not exposed on both sides of the connection, remove the nut and bolt and discard. Continue with step 5.

5. Position the shaft yoke connection to align the bolt hole with the groove in the spined end, and install a new pinch bolt and nut.
6. Use a calibrated torque wrench and a backing wrench on the bolt head. Set the torque wrench to 30 lbf-ft (41 N·m) and tighten from the nut side.
7. Apply torque seal to the exposed pinch bolt threads and nut.
8. Remove the lower dash panel. See **Fig. 2**, and reference the *Western Star Workshop Manual Section 60.06.100* for removal instructions.

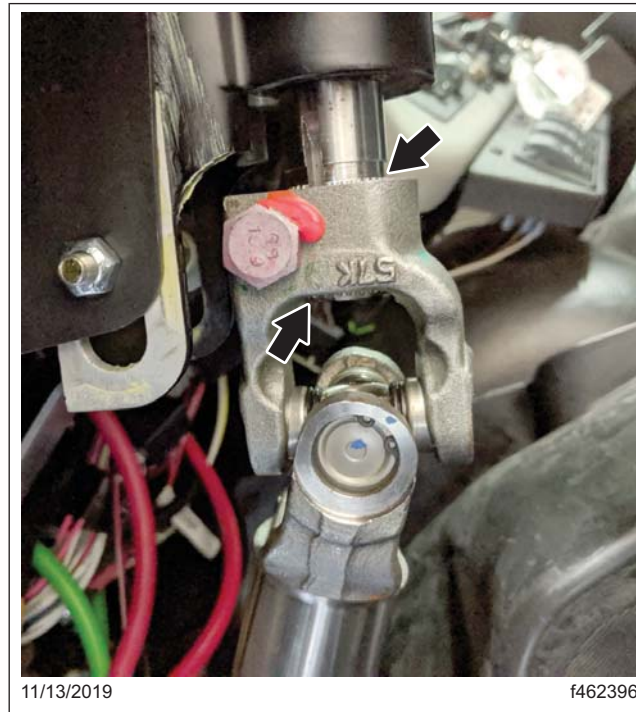
**Fig. 4, Steering Shaft Splines**

10. Inspect the connection where the stub-shaft yoke connects to the splined end of the steering column as shown in [Fig. 4](#).

If splines are correctly inserted and visible on both sides of the connection as indicated by the arrows, **NO replacement parts** are required. Go to step 12.

If the splines are not exposed on both sides of the connection, remove the nut and bolt and discard. Continue with step 11.

11. Position the shaft yoke connection to align the bolt hole with the groove in the splined end, and install a new pinch bolt and nut.
12. Use a calibrated torque wrench and a backing wrench on the bolt head. Set the torque wrench to 30 lbf-ft (41 N·m) and tighten from the nut side.
13. Apply torque seal to the exposed pinch bolt threads and nut.
14. Reinstall the steering column cover.
15. Reinstall the lower dash panel
16. Clean a spot on the base label (Form WAR259), write the recall number, FL835, on a blank red completion sticker (Form WAR260), and attach it to the base label to show this work has been completed.
