Campaign - Hitch Bracket Replacement

REPLACEMENT INSTRUCTION Bulletin No. 2019-1

Systems affected EBB-80 Trailer Units

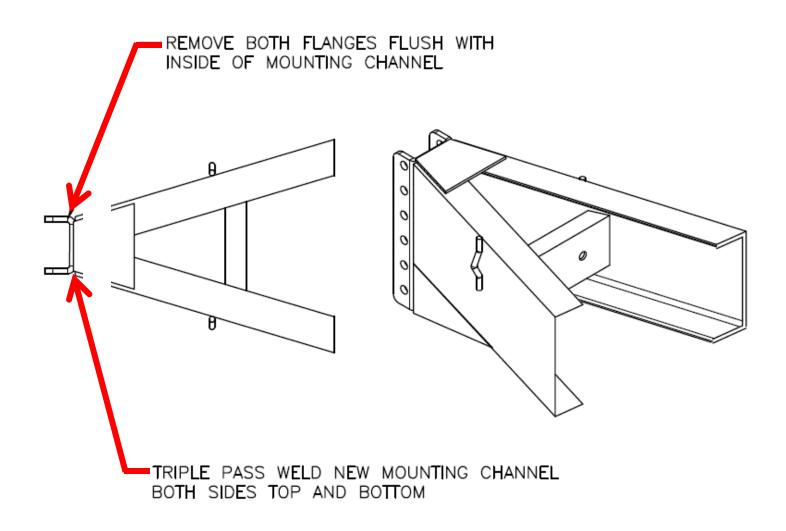
Illustration 1

The coupler rail rating on EBB-80 trailers has been found to not match the rating of the coupler used, affecting the adjustability of the hitch, and the ability of the user to safely set up the towing vehicle combination. Hitch parts are rated in excess of the trailer GVWR. A new bracket and retrofit instructions is provided.

- 1. Disconnect the negative terminal of the trailer's engine battery. Caution: Insure the trailer is disconnected from tow vehicle, level and chocked from movement before attempting work.
- 2. Unbolt existing coupler and retain coupler and fasteners for reassembly later.
- 3. Cut existing U-channel mounting rail, and weld in new part as depicted (next page).
- 4. Re-install coupler and fasteners, insuring that hitch height matches the hitch height of the tow vehicle. Torque fasteners to 150 FT-LB, ungreased.
- 5. Reconnect engine battery.
