CR183 – Battery fastening updates

Hypermotard 950 Model Year 2019-2020

Hypermotard 950 SP Model Year 2019-2020

Safety Recall Campaign SRV-RCL-19-003

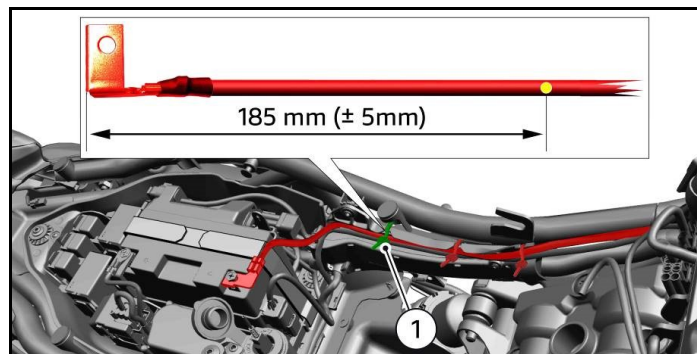
Ongoing product quality tests have identified a remote potential that the battery negative cable may fracture at the terminal retaining it to the corresponding battery pole, due to excessive tension on the cable.

Check, and adjust if required, the length of battery negative terminal cable free section between the end of terminal and **tie (1)** is **185 ± 5 mm**
