TO: Mercedes-Benz and Freightliner Dealer Principals, General Managers, Sales Managers, Service Managers, Parts Managers	FROM: Anthony Washington, Department Manager, Regulations and Certifications
RE: Recall Campaign Notification Model 907 (Sprinter) Model Years 2019 Locking Fuel Pump	DATE: December 13, 2019

Campaign VS3KRAFMOD, January 2019

SUBJECT: **Model 907 (Sprinter), Model Year 2019
Locking Fuel Pump**

Mercedes-Benz AG ("MBAG"), the manufacturer of both Mercedes-Benz and Freightliner vehicles, has determined that on certain Sprinter vehicles (platform 907 (VS30)) with diesel fuel systems, the bayonet lock between the fuel pump and the fuel tank may not have been closed and locked during the reassembly process. If this bayonet lock is not closed and locked according to specification, a leak could occur between the fuel pump and the fuel tank and a gas station fuel pump may not automatically stop once the respective tank fill level is reached. An authorized Mercedes-Benz or Freightliner Sprinter dealer will check the bayonet lock on the fuel pump to determine if it has been correctly locked and will lock it correctly if necessary.

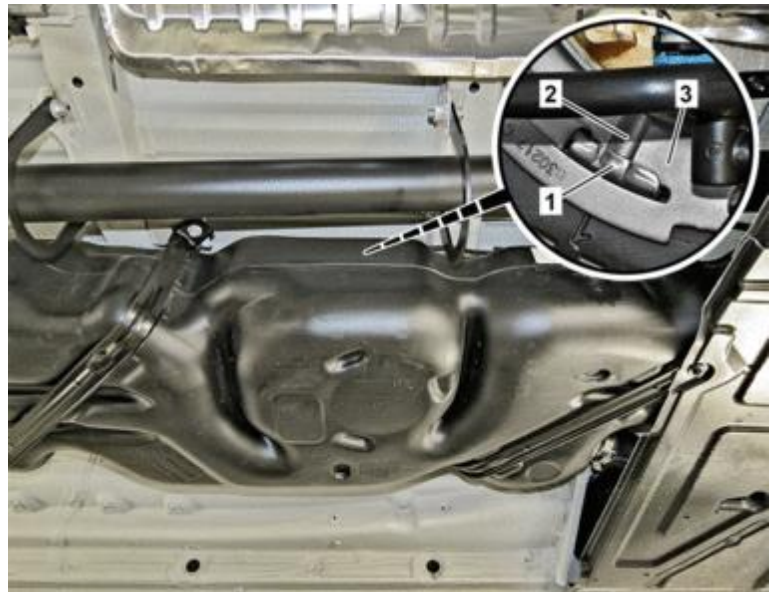
Figure 1: D47.20-A008-81

- 1 Lock
- 2 Catch
- 3 Locking ring

To do so, the catch (2) of the locking ring (3) must be engaged in the center curvature of the lock (1) (see picture A).</p> <p>If the catch (2) of the locking ring (3) is correctly locked in the lock (1),</p> <p>↓</p> <p>continue with operation step 7.</p> <p>If the catch (2) of the locking ring (3) in the lock (1) is not correctly locked (see pictures B, C),</p> <p>↓</p> <p>continue with operation step 4.</p>	
Remove			
4	Lower fuel tank.	<p>If the locking ring (3) is not correctly locked.</p> <p>

To do so, position I claw wrench on the locking ring (3) and turn clockwise until the catch (2) of the locking ring (3) engages in the center curvature of the lock (1) (see picture A).</p> <p>

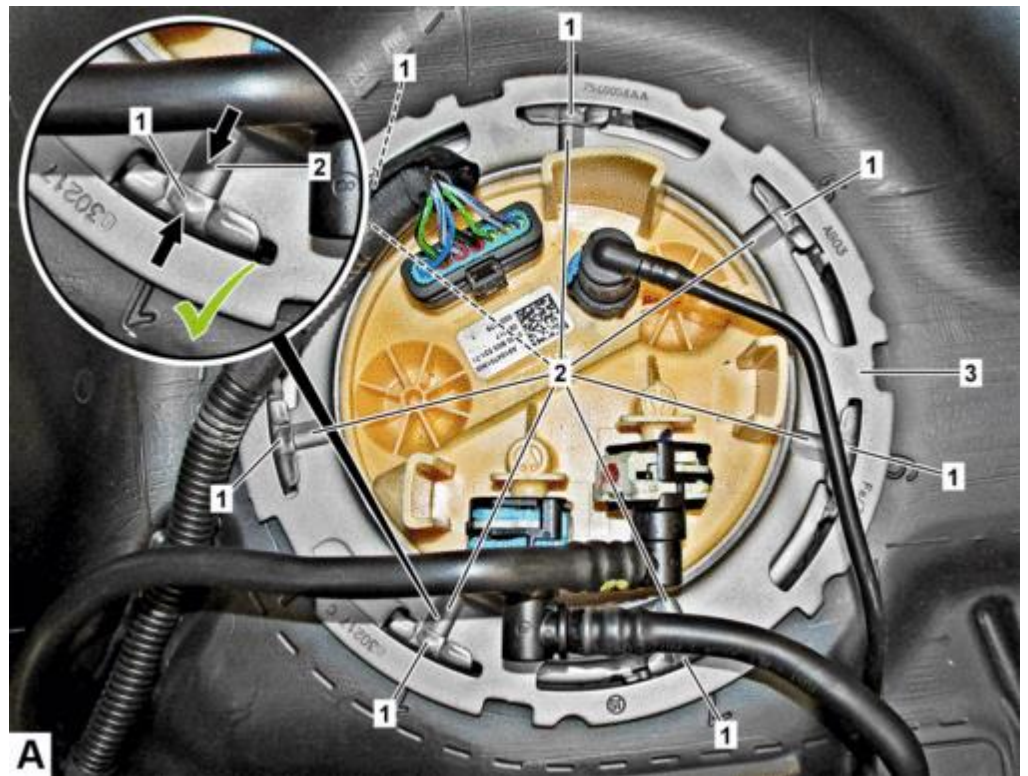
Figure 2: D47.20-A009-76

- 1 Lock
- 2 Catch
- 3 Locking ring

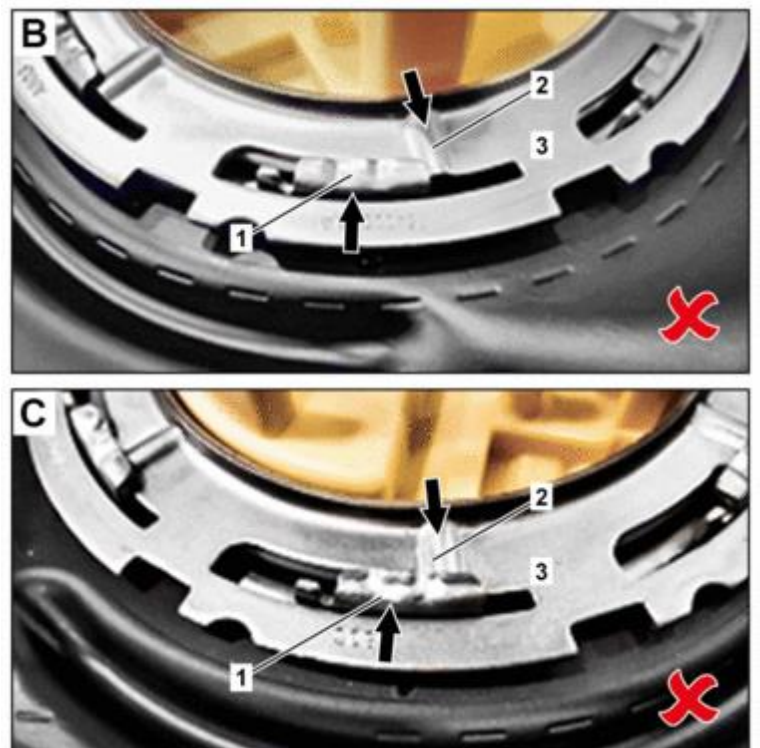
Figure 3: D47.20-A010-82

- 1 Lock
- 2 Catch
- 3 Locking ring
