David J. Johnson
Director
Service Engineering Operations
Ford Customer Service Division

November 13, 2019

SUBJECT: NEW VEHICLE DEMONSTRATION / DELIVERY HOLD - Safety Recall 19S40
Certain 2019-2020 Model Year F-150 Vehicles
Battery Monitoring Sensor Eyelet Adhesive Obstruction

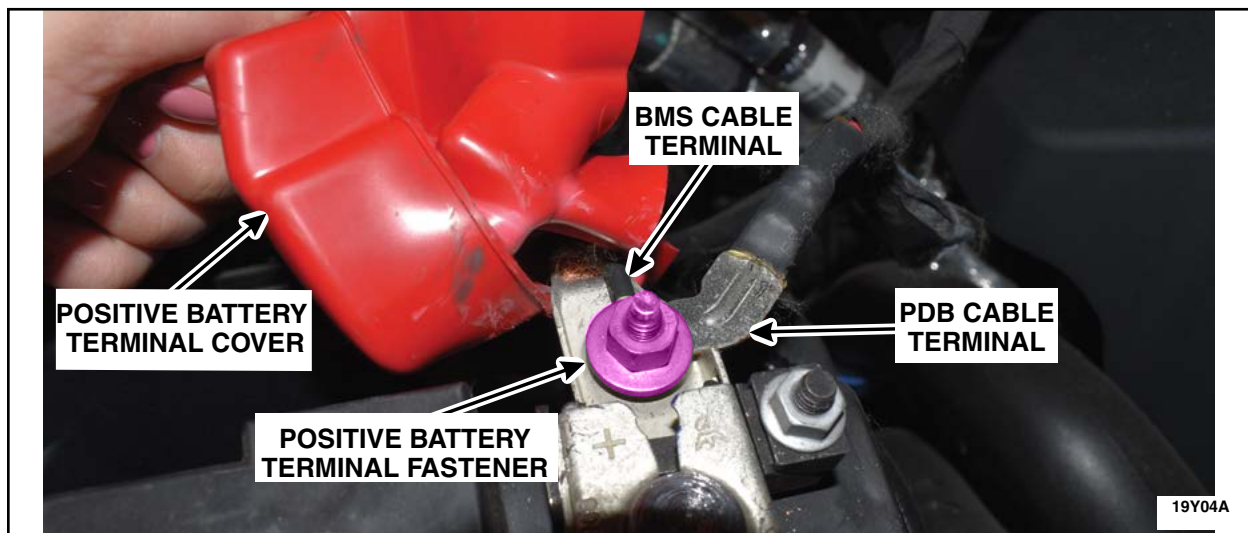
FIGURE 1

1. Disconnect the negative battery cable and position aside. Please follow the Workshop Manual (WSM) procedures in Section 414-01.
2. Position the positive battery terminal cover aside and remove the positive battery terminal fastener. See Figure 1.
 - Torque to 177 lb.in (20 Nm).

6. Reassemble the vehicle by reversing the removal steps. Re-torque the positive battery terminal fastener to specification.

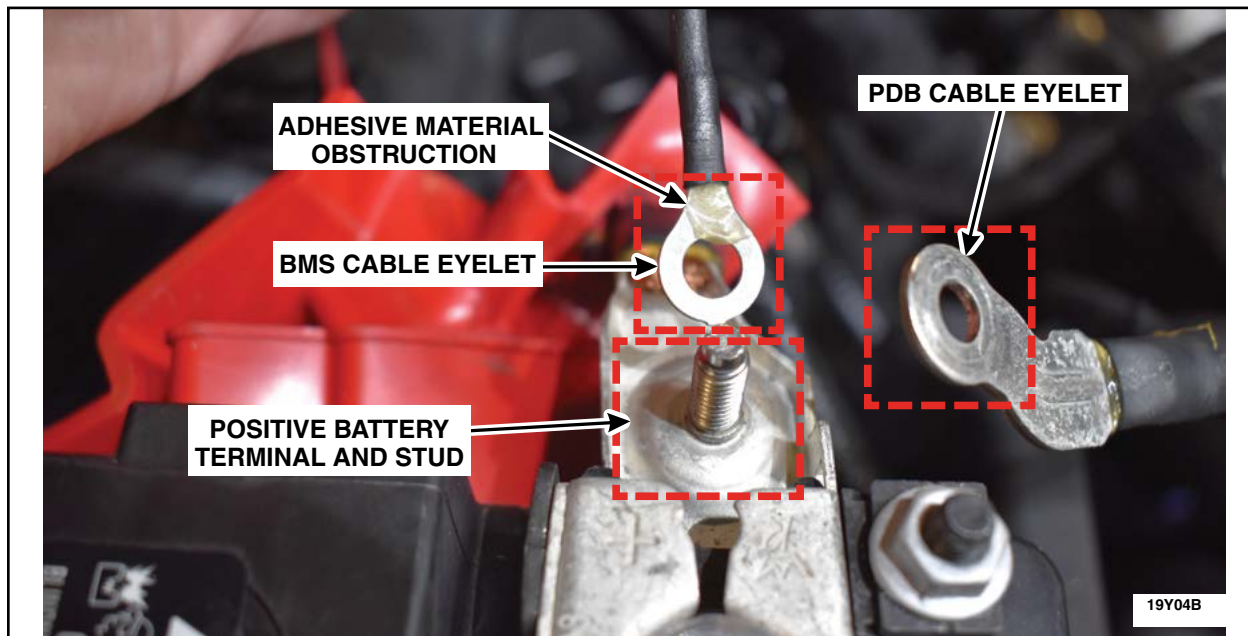
FIGURE 2

3. Remove the PDB cable and the BMS cable from the positive battery terminal stud.
4. Thoroughly inspect the positive battery terminal fastener joint (PDB cable eyelet, BMS cable eyelet and positive battery terminal with stud) for excessive heat shrink tubing adhesive. Inspect the highlighted areas including both the top and bottom surfaces of the BMS and PDB cable eyelets. See Figure 2.

5. Remove any heat shrink tubing adhesive from the positive battery terminal joint using a suitable hand held razor blade tool.

CAUTION: Use caution not to damage the eyelets, cable wiring, or heat shrink tubing while removing the excess adhesive material.
