SAFETY RECALL ACTION

Reference number:	RA-01-1327	Issued: 13 November, 2019
Subject:	Incorrect Installation of the Passenger Airbag	
Model(s):	DB11, Vantage (19MY), DBS Superleggera	
VIN Range:	Refer to the separately published list of Vehicle Identification Numbers (VINs)	
Applicable to:	All Dealers	
Distribute to:	After Sales Manager Executive Manager Service Manager Sales Manager	Warranty Staff Technician(s) Parts Staff

Safety Recall Action RA-01-1327 – Incorrect Installation of the Passenger Airbag

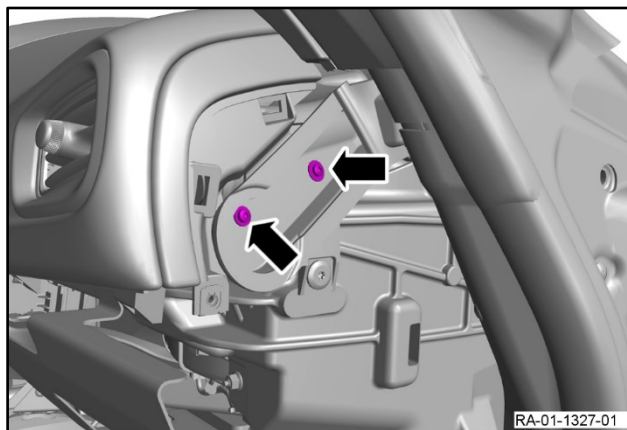
Figure 3

1. Remove the passenger side bottom panel for the IP (refer to Workshop Manual procedure 01.12.DV).
2. Remove the two screws that attach the duct for the door (refer to Figure 3).

7. Install the duct for the door (refer to Figure 4).
8. Install the two screws that attach the duct for the door (refer to Figure 3).
9. Install the passenger side bottom panel for the IP (refer to Workshop Manual procedure 01.12.DV).

4. Install the duct feed for the door (refer to Figure 4).
5. Install the two screws that attach the duct feed for the door (refer to Figure 3).
6. Install the right side end cover for the IP (refer to Workshop Manual procedure 01.12.BK).

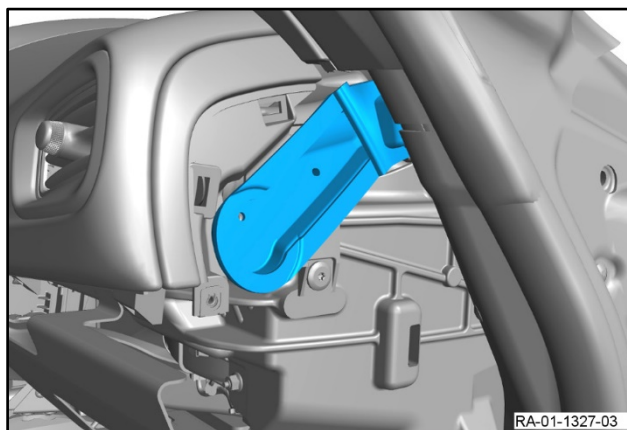
Figure 4

3. Remove the duct for the door (refer to Figure 4).

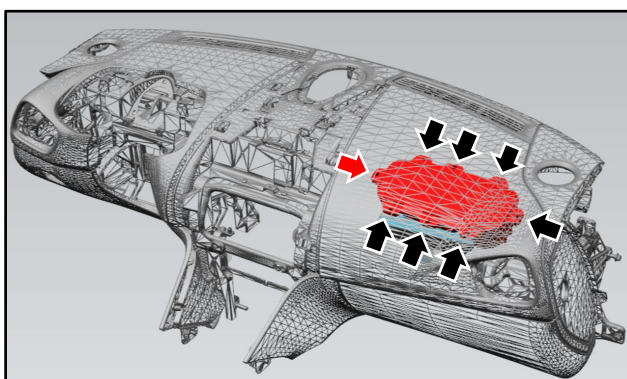
Figure 5

4. Use a fibre-optic camera to inspect the seven locking nuts that are accessible in the locations shown (refer to Figure 5).

Note: There are eight locking nuts in total, but one locking nut is not visible (refer to the red arrow).

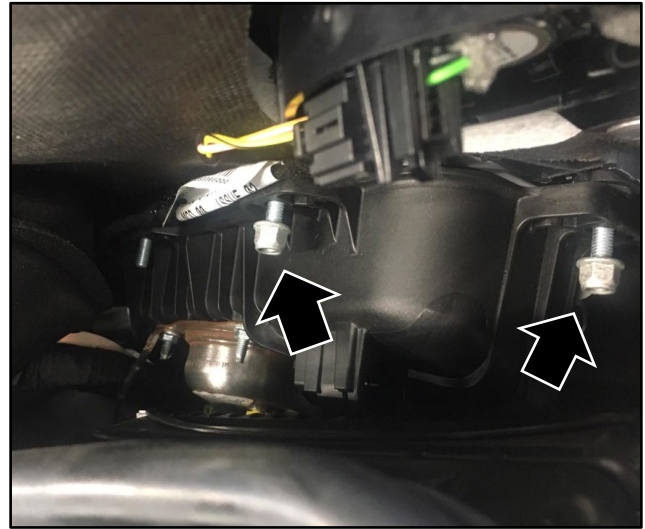
Figure 6

On the affected vehicles, it is possible the locking nuts that attach the passenger airbag to the instrument panel (IP) are not torqued to the correct specification.

5. If any of the locking nuts are not installed correctly (refer to Figure 6) go to Part B: Torque the Locking Nuts to the Correct Specification.

WARNING: IF A LOCKING NUT IS MISSING, INSTALL A NEW LOCKING NUT WITH THE PART NUMBER GIVEN IN THE PART DATA. IF YOU DO NOT USE THE CORRECT PART, IT IS POSSIBLE THAT THE AIRBAG WILL NOT BE ATTACHED CORRECTLY IN THE EVENT OF AN ACCIDENT AND NOT DEPLOY CORRECTLY.

2. Torque the eight locking nuts that attach the passenger airbag to the IP to 6.5 Nm.
3. Install the front evaporator and heater assembly (refer to Workshop Manual procedure 12.03.AH).

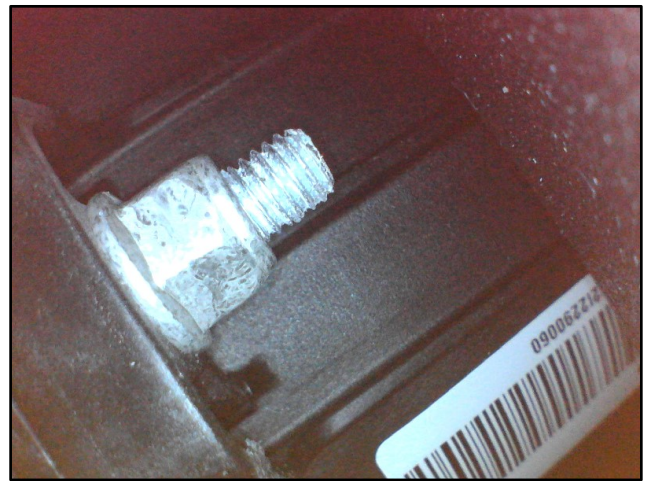
Figure 7

6. If all the locking nuts have been installed correctly (refer to Figure 7) go to step 7.
