Dealer Service Instructions for:

Safety Recall VB8 / NHTSA 19V-812

Electric Power Steering Gear

2019 (DS) Ram 1500 Pickup

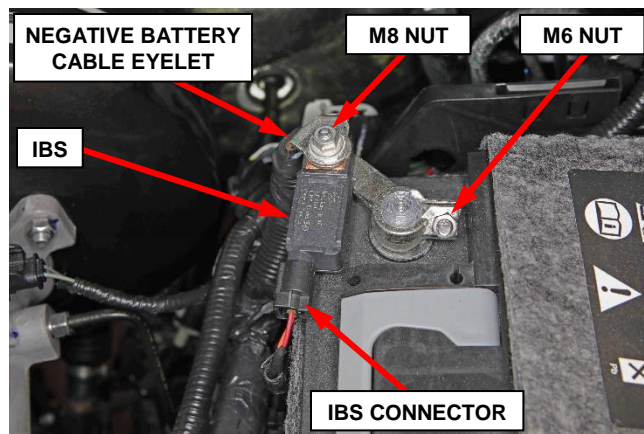
Figure 2 – Vehicle Battery

NOTE: Do not remove the M6 captive nut, doing so may cause the M6 stud on the battery cable clamp with IBS to break (Figure 2).

NOTE: The M8 negative battery cable eyelet nut has a higher torque than the M6 battery cable clamp with IBS nut and can break the IBS free if the M6 nut is tightened first.

5. Disconnect the Intelligent Battery Sensor (IBS) wire harness connector (Figure 2).

6. Remove the M8 negative battery cable eyelet nut (Figure 2).

7. Remove the negative battery cable eyelet and isolate the negative battery cable away from the IBS negative cable terminal (Figure 2).

8. Loosen the M6 battery cable clamp with IBS captive nut (Figure 2).

16. Install the negative battery cable eyelet on the IBS M8 stud (Figure 2).
17. Connect the IBS wire harness connector. Make sure there is no stress on the wires (Figure 2).
18. Install and tightening the M8 negative battery cable eyelet nut to 16 N·m (12 ft. lbs.) (Figure 2).

19. Tighten the M6 battery cable clamp with IBS nut to 6 N·m (53 in. lbs.) (Figure 2).
