Recall Campaign Launch Notification			March 13, 2020
Campaign No. :	NHTSA ID	Campaign Desc. :	Routing of Door Wiring Harness
2020020021	19V820	19P5491016	
<p>This is to notify you of a Recall Campaign Launch regarding the routing of the door wiring harness in 2,427 Model Year (“MY”) 19 G-Class (463 platform) vehicles. The recall campaign will be visible on the www.safercar.gov website and may generate questions from customers. Affected VINs will be flagged in VMI as “OPEN” on March 13, 2020.</p>			
Background			
Issue	<p>Mercedes-Benz AG (“MBAG”), the manufacturer of Mercedes-Benz vehicles, has determined that on certain MY 2019 G-Class vehicles (463 platform), the front door wiring harnesses might not be routed according to current production specifications. If the front door wiring harness is not routed according to current production specifications, the opening and closing of the front doors might cause individual wires to become damaged. Damage to certain wires could affect the performance of certain safety features such as the side impact restraint system, the automatic unlocking of the door in the event of a crash, or the vehicle location in the event of an emergency call. Im

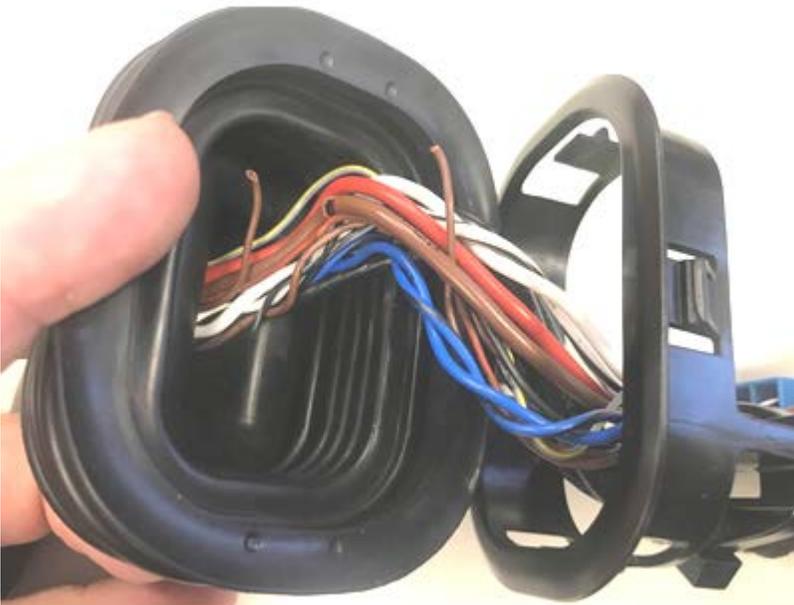
Figure 4 NOT OK

5. Check the wiring harness between the retaining frame and the door for damage.

i Figure 4 shows a state that is not OK.

- a. If the wiring harness **is not** damaged: Carry out **work procedure A**.
- b. If the wiring harness **is** damaged: Carry out **work procedure B**.
