## SIB 52 24 19

2020-04-06

### RECALL 19V-823: ISOFIX CHILD SEAT ANCHORS

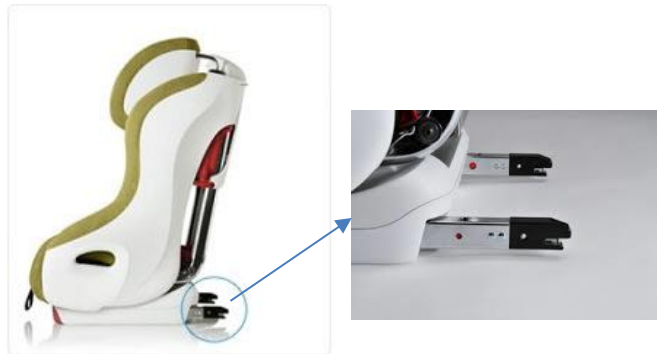
This Safety Recall involves the lower anchor bars in the vehicle's rear seat when specifically attaching a child seat with ISOFIX-type rigid-style connectors. **This condition is unlikely to occur using LATCH-type flexible-style connector child seats which are the vast majority of child seats used in the US.** Should rigid-style connectors be used, the lower anchor bars could become damaged over the lifetime of the vehicle. If the lower anchor bar(s) became damaged, this could increase the risk of injury to a child in an ISOFIX-type child seat during a crash.

Please refer to the image below illustrating a child seat with rigid-style connectors.
