Product Safety Recall

N192286810 Rear Outer Wheel Nut Inspection and Torque

Release Date: November 2019 Revision: 00

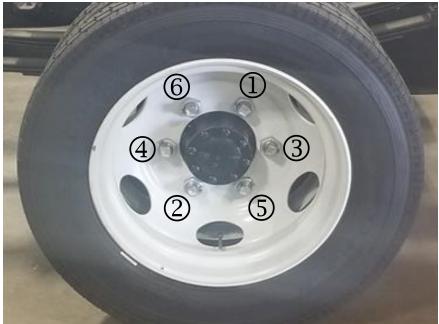
5445487

Condition	Isuzu Motors Limited has decided that a defect, which relates to motor vehicle safety, exists in certain				
	2019-2020 Chevrolet 4500 HD/XD & 5500 HD/XD Medium Duty Trucks equipped with diesel engines				
	and manufactured by Isuzu Japan. In some of the affected vehicles, the rear outer wheel lug nuts may				
	not have been properly tightened and/or torqued when installed onto the rear axles at the Baltimore port.				
	The lug nuts may loosen and the wheel may ultimately separate from the vehicle, increasing the risk of				
	a crash and/or injury to persons or property.				
Correction	Dealers will inspect the rear outer wheel lug nuts to assure they have been torqued to specification on				
	all involved trucks, replacing any missing lug nuts.

NOTE: Driver side rear outer wheel nuts are left-hand threaded and must be torqued counter-clockwise.

3. Using a torque wrench, tighten all of the driver and passenger side rear outer wheel lug nuts to 500 Nm (362 lb ft) in the sequence shown above.
