Product Safety Recall

N192286810 Rear Outer Wheel Nut Inspection and Torque

Release Date: January 2020

Revision: 01

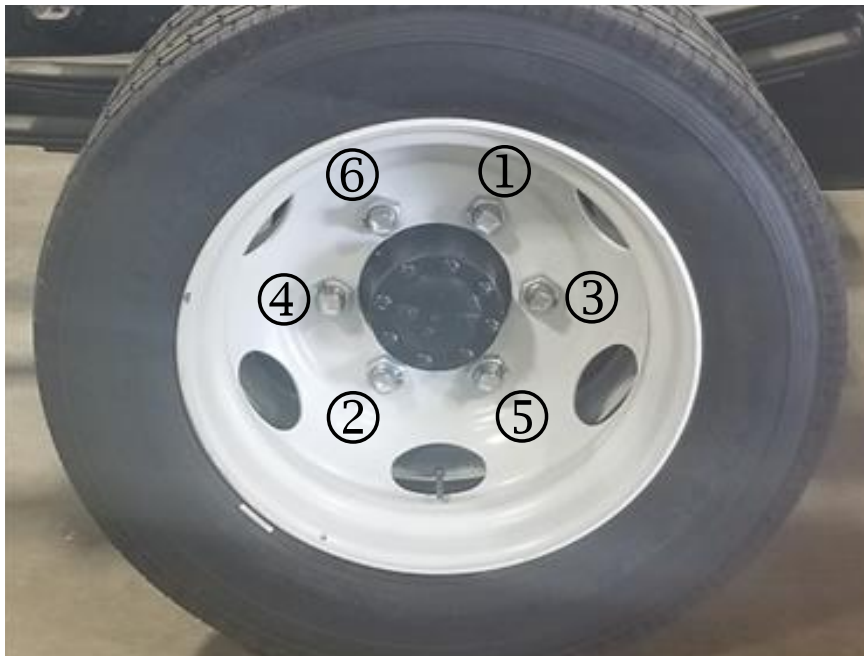
5445487

NOTE: Driver side rear outer wheel nuts are left-hand threaded and must be torqued counter-clockwise.

- Using a torque wrench, tighten all of the driver and passenger side rear outer wheel lug nuts to 500 Nm (362 lb ft) in the sequence shown above.
