December 9, 2019

**SUBJECT: NEW VEHICLE DEMONSTRATION / DELIVERY HOLD -
 Safety Recall 19S43 – Supplement #1**
 Certain 2019 Model Year Ranger Vehicles
 Rear Tail Lamps

CERTAIN 2019 MODEL YEAR RANGER VEHICLES — REAR TAIL LAMP WIRING

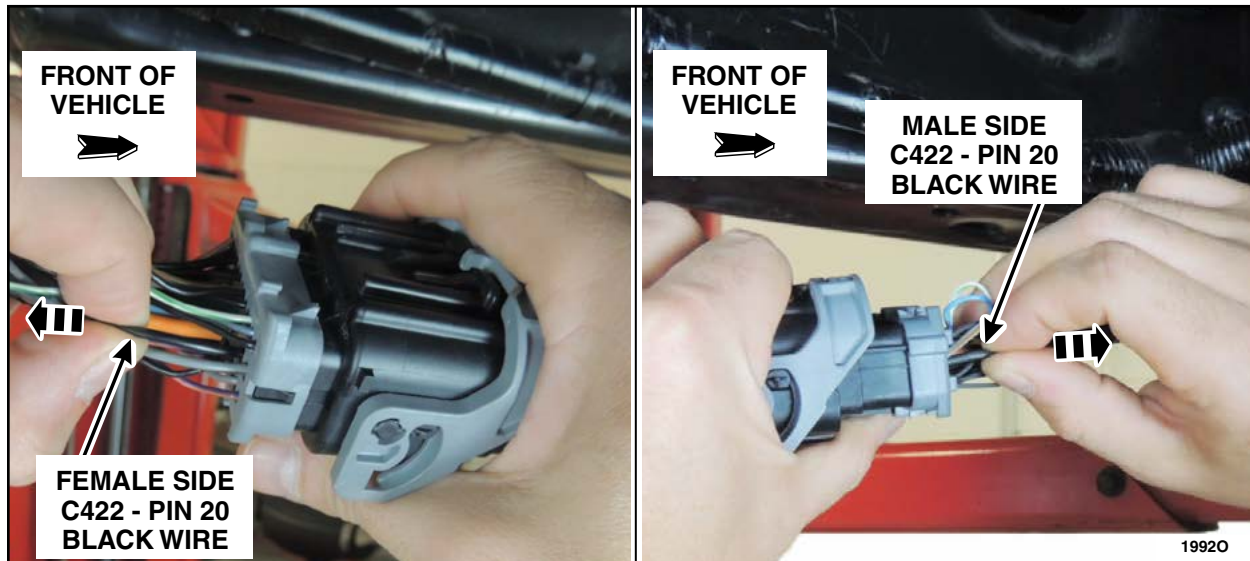
FIGURE 11

11. At connector C422, using your fingers pull outward on pin 20 (BK wire) on both sides of the C422 connector. Only apply enough pulling force to ensure the terminal is locked into the connector. Listen for the volt/ohm meters audible tone to either stop or intermittently break up as you pull on pin 20 (BK wire). If the terminal pulled out of the connector hard shell or the meters audible tone stop or intermittently broke up, record the side of the connector and the pin number on the repair order. Whether or not the terminal pulled out of the connector hard shell proceed to the next Step. See Figures 11, 12 and 13.

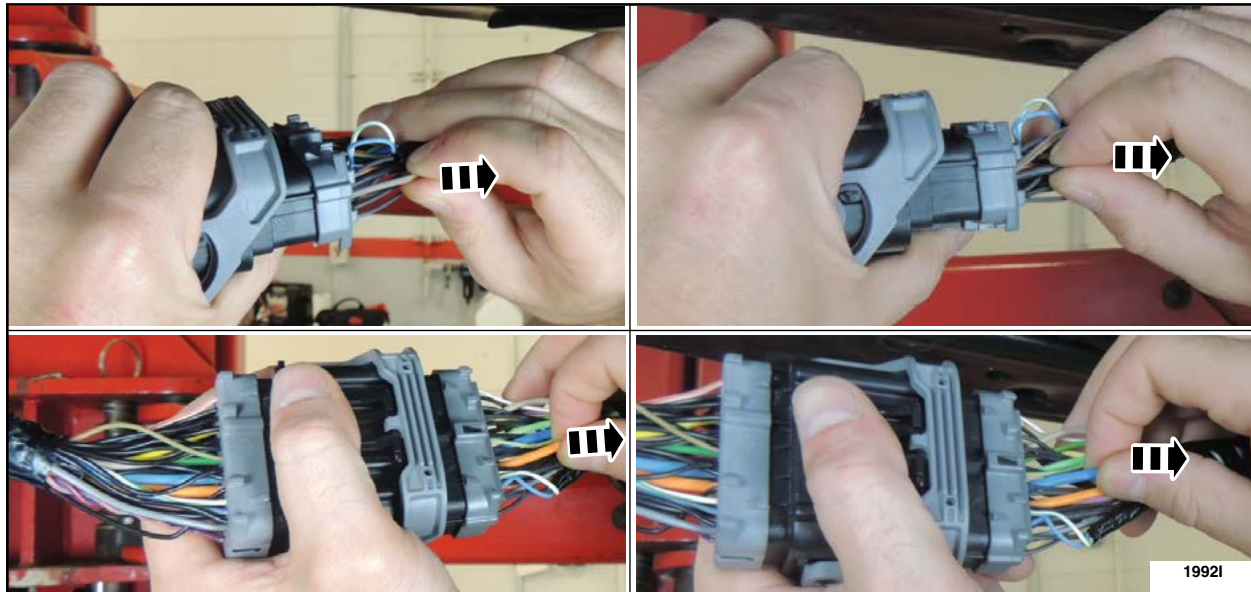
FIGURE 14

14. At connector C422, using your fingers pull on the remaining wires in the center row of terminals wires (cavities 14-19 and 21) on both male and female connector sides, checking for any terminals that may be push out of the connector hard shell. See Figures 12, 13 and 14.

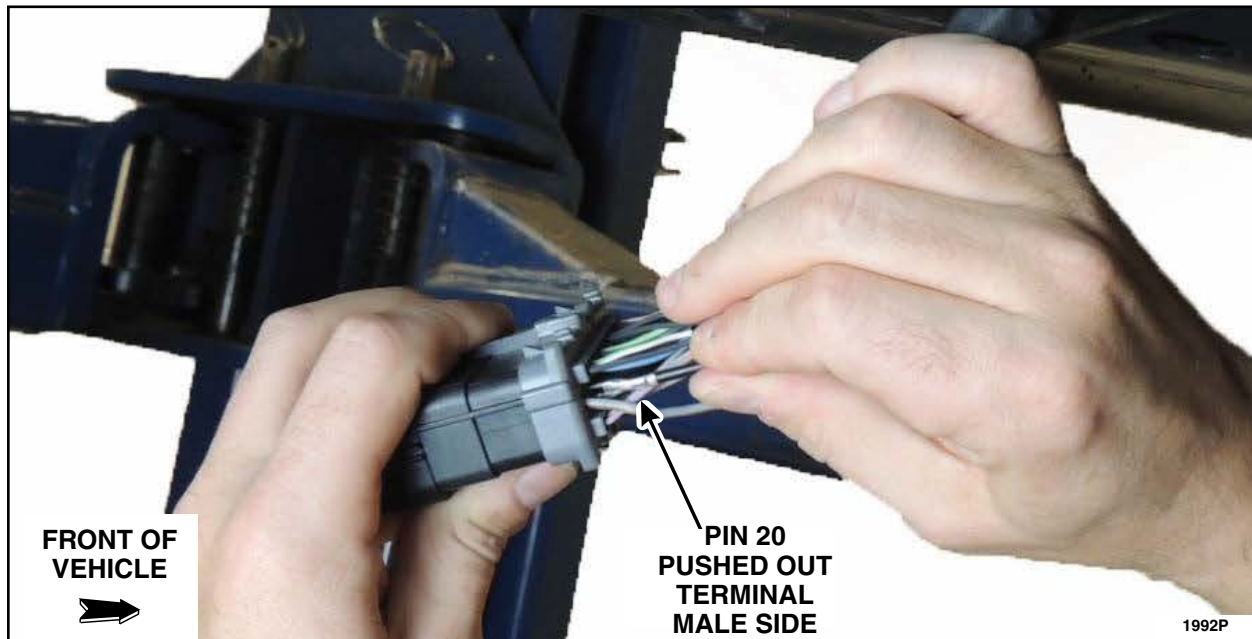
FIGURE 15

15. Were any of the wires in the center row of terminals on the male or female side of C422 pushed out of the connector hard shell and/or did the volt/ohm meters audible tone either stop or intermittently break up as you pulled on pin 20 (BK wire) in Step 11? See Figure 15.

NOTE: Pin terminal 20 of the male side connector shown, all pin terminals similar.

Yes - Record the connector side and cavity number on the repair order, then proceed to Step 16.
No - Proceed to Vehicle Reassembly on Page 27.

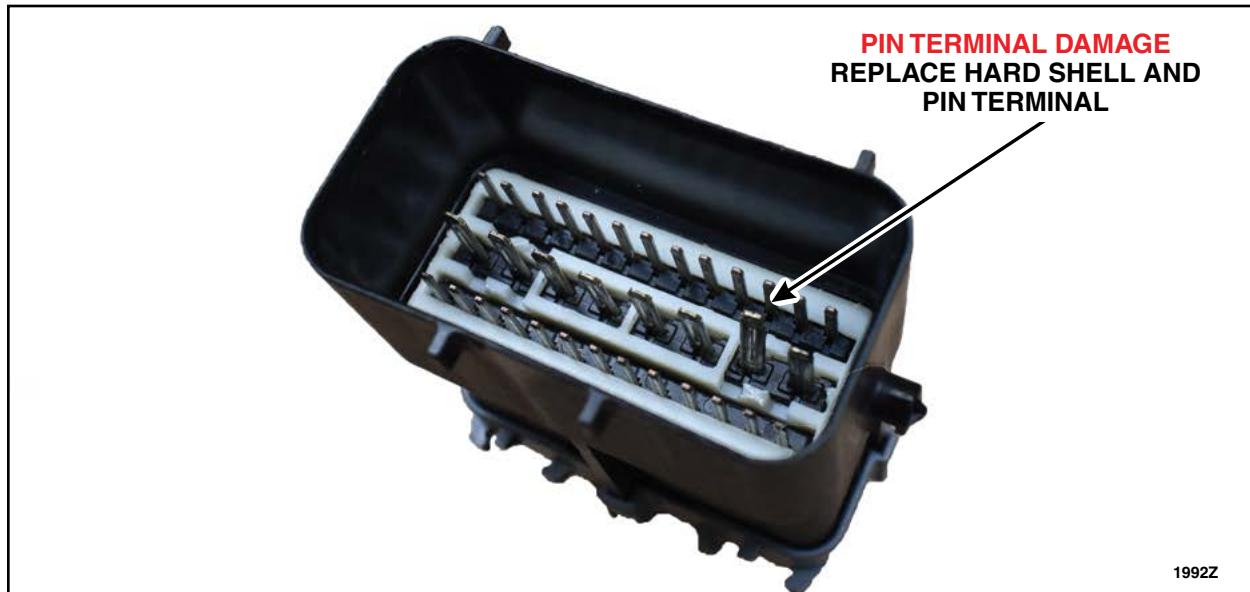
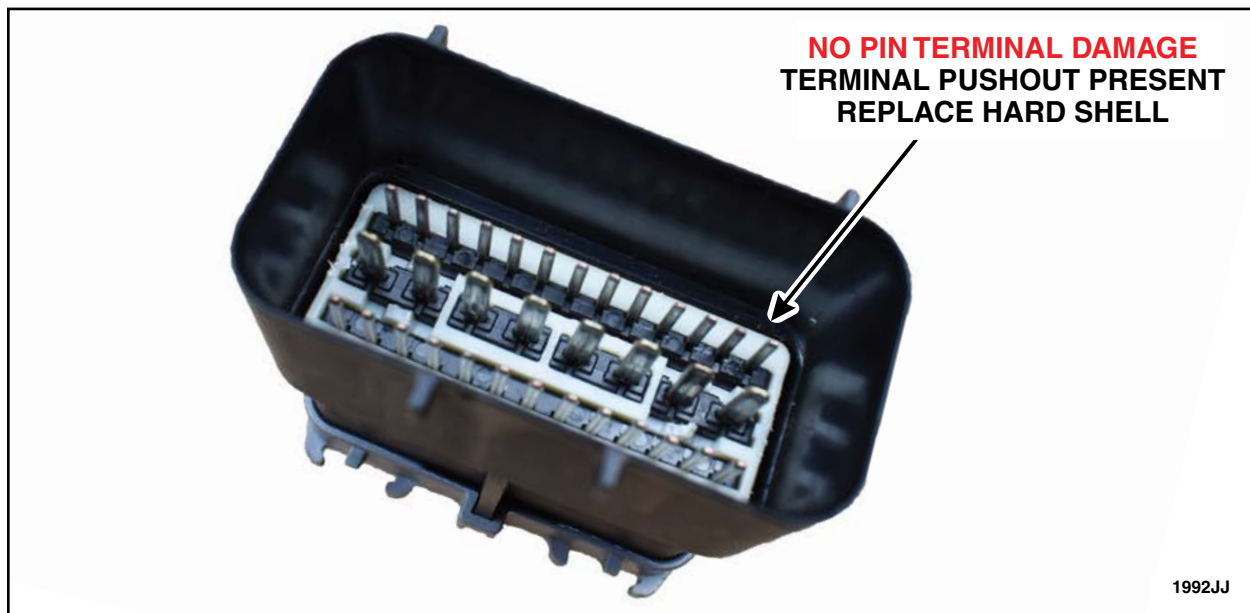
17. Inspect all of the wire terminal(s) on both connectors, and complete connector and terminal replacement as required. See Figures 17 and 18.
- Replace the connector hard shell on the side(s) the pushed out terminal(s) were found. Refer to C422 Male and Female Side - Pigtail Connector Depinning Procedure.
 - Replace any damaged pin terminals that are found on either connector. Refer to C422 Male or Female Terminal Replacement Procedure.

NOTE: Only replace the connector hard shell and/or a damaged pin terminal on the side the pushed out and/or damaged terminal(s) were found.
