David J. Johnson
 Director
 Service Engineering Operations
 Ford Customer Service Division

**SUBJECT: NEW VEHICLE DEMONSTRATION / DELIVERY HOLD -
 Safety Recall 19S43 – Supplement #4**
 Certain 2019 Model Year Ranger Vehicles
 Rear Tail Lamps

CERTAIN 2019 MODEL YEAR RANGER VEHICLES — REAR TAIL LAMP WIRING

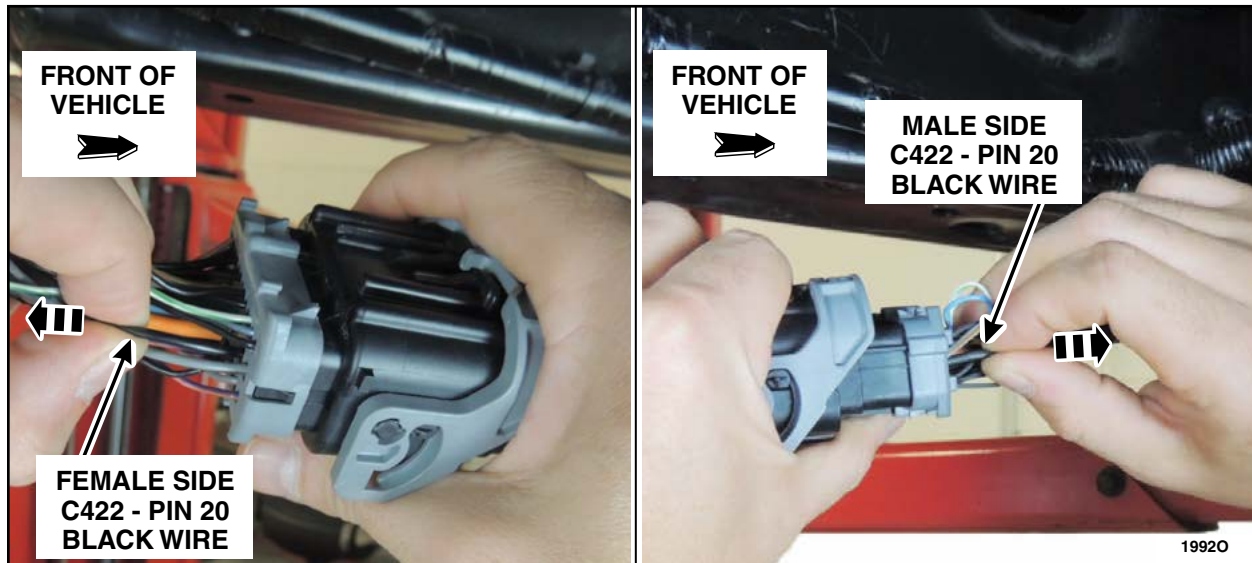
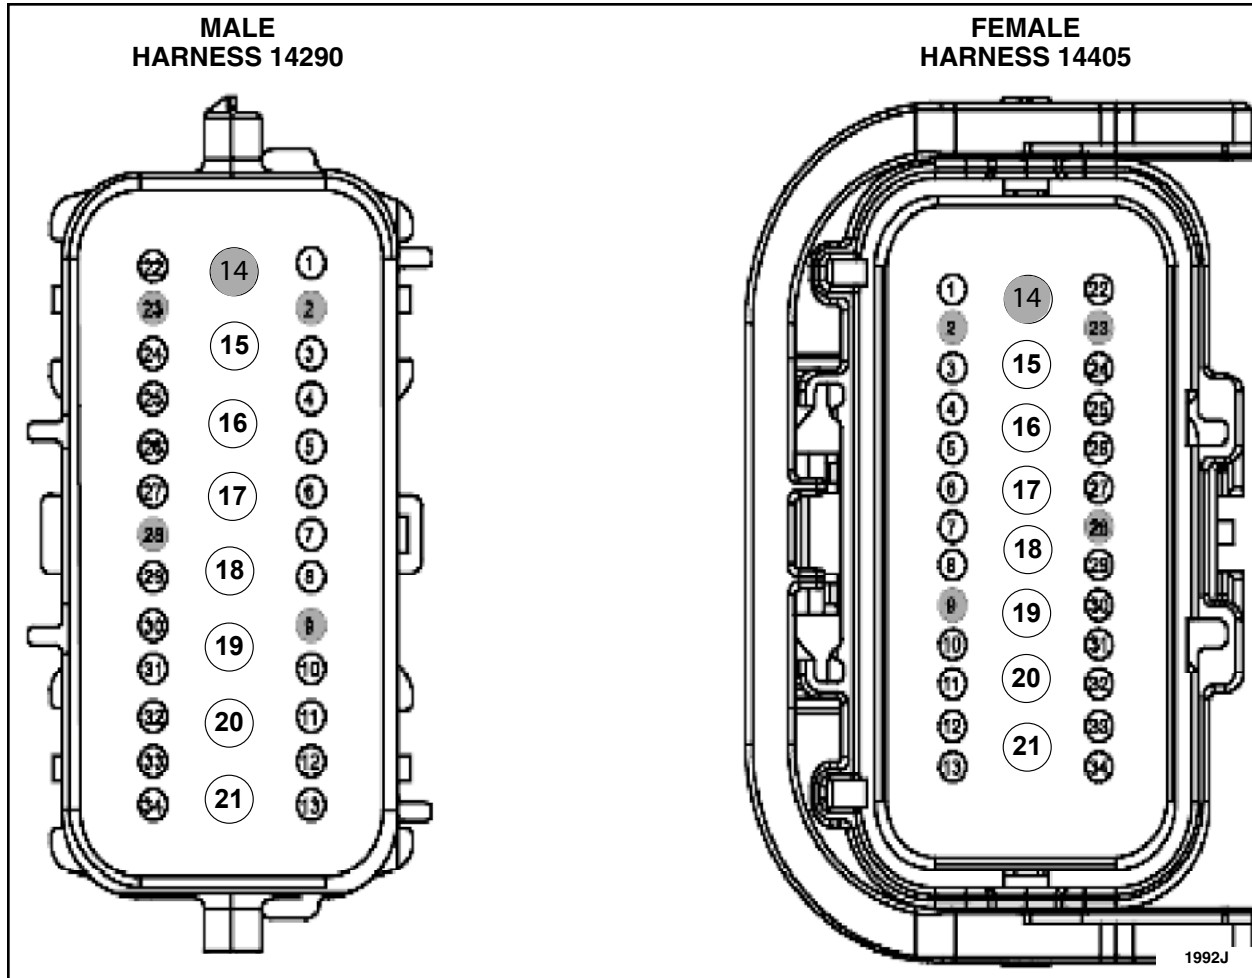
FIGURE 11

11. At connector C422, using your fingers pull outward on pin 20 (BK wire) on both sides of the C422 connector. Only apply enough pulling force to ensure the terminal is locked into the connector. Listen for the volt/ohm meters audible tone to either stop or intermittently break up as you pull on pin 20 (BK wire). If the terminal pulled out of the connector hard shell or the meters audible tone stop or intermittently broke up, record the side of the connector and the pin number on the repair order. Whether or not the terminal pulled out of the connector hard shell proceed to the next Step. See Figures 11, 12 and 13.

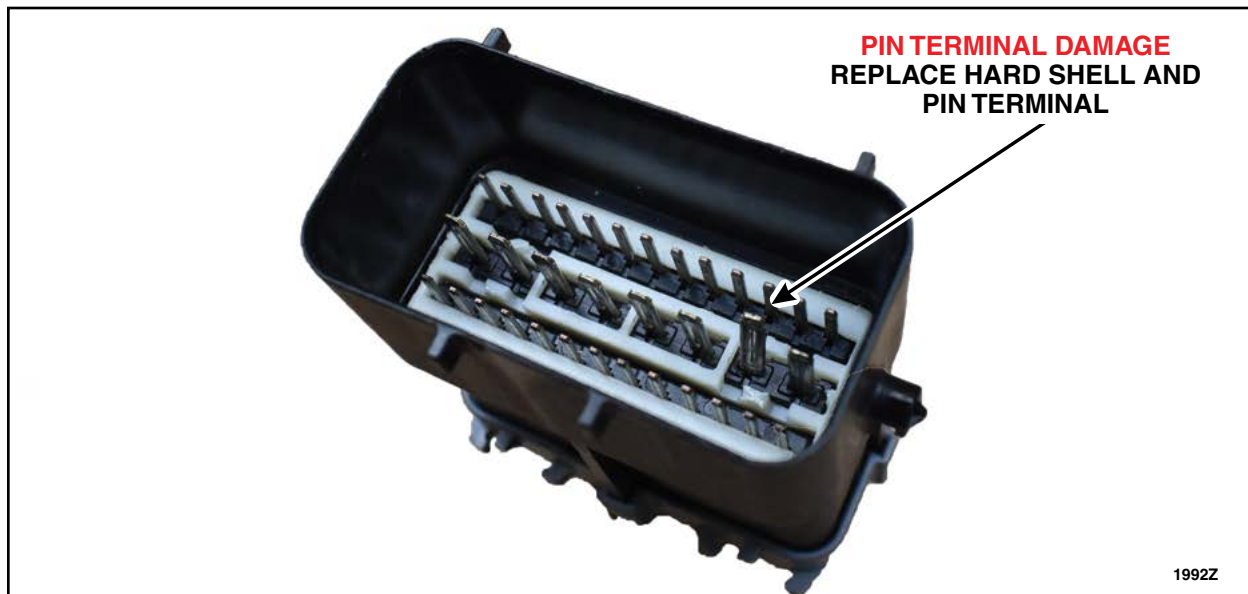
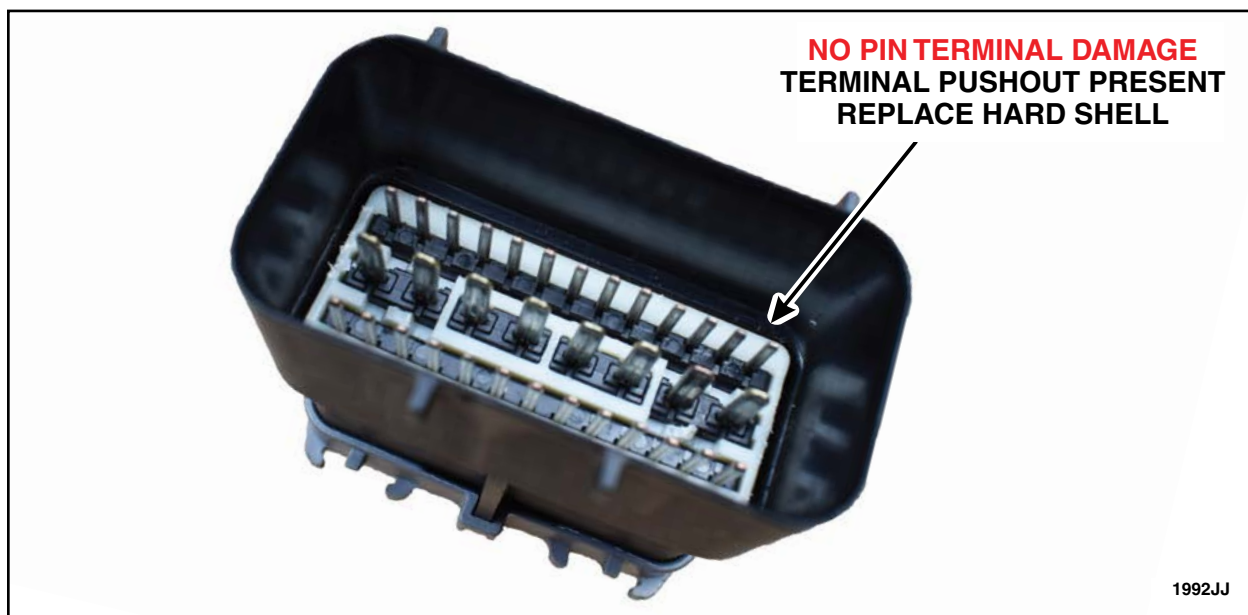
FIGURE 17

17. Inspect all of the wire terminal(s) on both connectors, and complete connector and terminal replacement as required. See Figures 17 and 18.
- Replace the connector hard shell on the side(s) the pushed out terminal(s) were found. Refer to C422 Male and Female Side - Pigtail Connector Depinning Procedure.
 - Replace any damaged pin terminals that are found on either connector. Refer to C422 Male or Female Terminal Replacement Procedure.

NOTE: Only replace the connector hard shell and/or a damaged pin terminal on the side the pushed out and/or damaged terminal(s) were found.
