**SUBJECT: NEW VEHICLE DEMONSTRATION / DELIVERY HOLD -
 Safety Recall 19S43 – Supplement #3**
 Certain 2019 Model Year Ranger Vehicles
 Rear Tail Lamps

**NEW VEHICLE DEMONSTRATION / DELIVERY HOLD -
Safety Recall 19S43 – Supplement #3
Certain 2019 Model Year Ranger Vehicles
Rear Tail Lamps**

CERTAIN 2019 MODEL YEAR RANGER VEHICLES — REAR TAIL LAMP WIRING

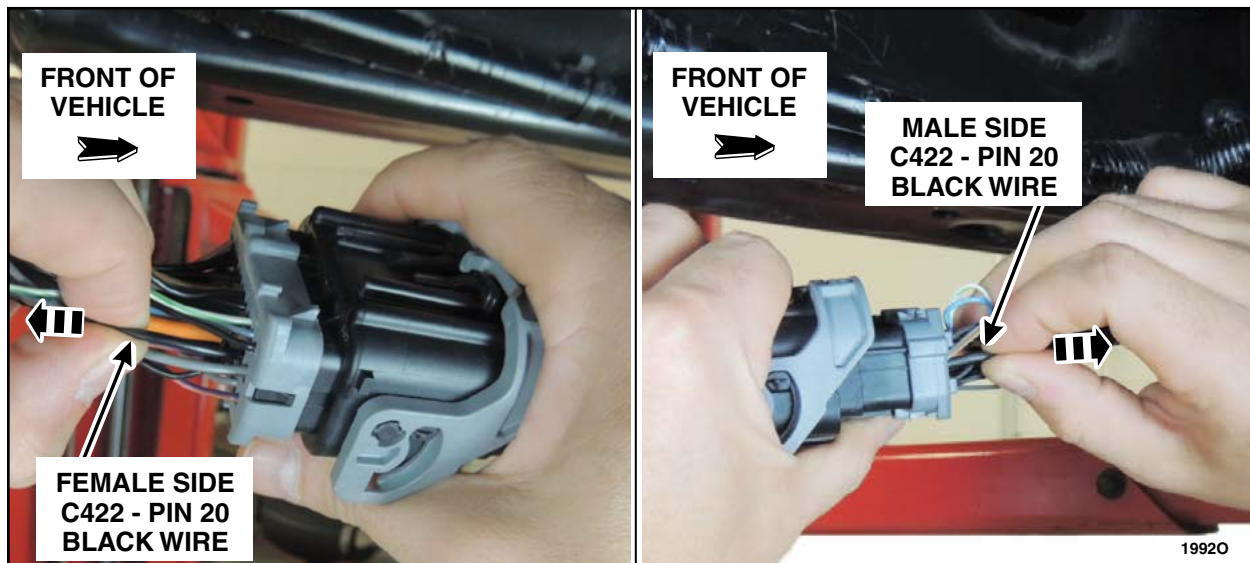
FIGURE 11

11. At connector C422, using your fingers pull outward on pin 20 (BK wire) on both sides of the C422 connector. Only apply enough pulling force to ensure the terminal is locked into the connector. Listen for the volt/ohm meters audible tone to either stop or intermittently break up as you pull on pin 20 (BK wire). If the terminal pulled out of the connector hard shell or the meters audible tone stop or intermittently broke up, record the side of the connector and the pin number on the repair order. Whether or not the terminal pulled out of the connector hard shell proceed to the next Step. See Figures 11, 12 and 13.

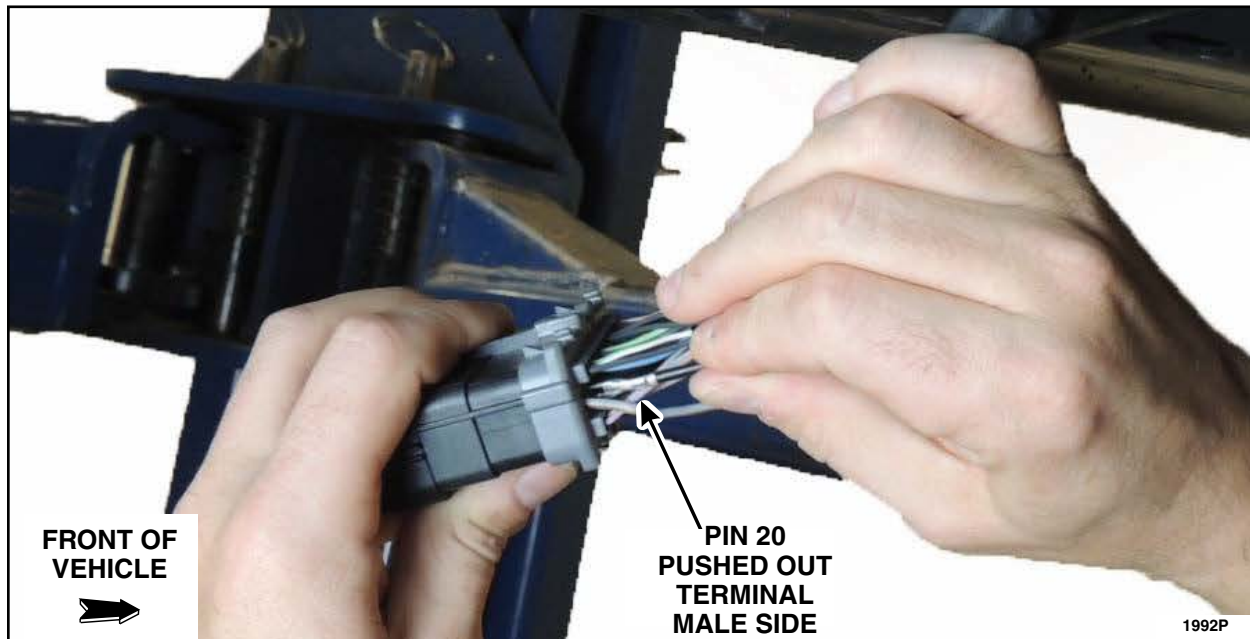
FIGURE 15

15. Were any of the wires in the center row of terminals on the male or female side of C422 pushed out of the connector hard shell and/or did the volt/ohm meters audible tone either stop or intermittently break up as you pulled on pin 20 (BK wire) in Step 11? See Figure 15.

NOTE: Pin terminal 20 of the male side connector shown, all pin terminals similar.

Yes - Record the connector side and cavity number on the repair order, then proceed to Step 16.
No - Proceed to Vehicle Reassembly on Page 27.

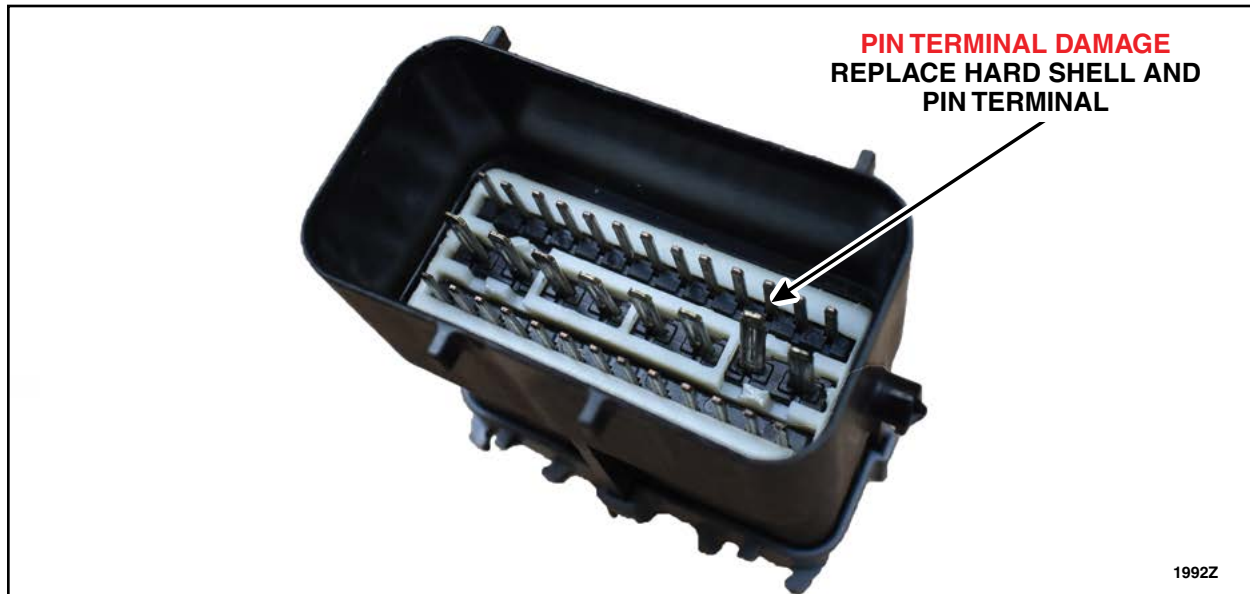
FIGURE 17

17. Inspect all of the wire terminal(s) on both connectors, and complete connector and terminal replacement as required. See Figures 17 and 18.
- Replace the connector hard shell on the side(s) the pushed out terminal(s) were found. Refer to C422 Male and Female Side - Pigtail Connector Depinning Procedure.
 - Replace any damaged pin terminals that are found on either connector. Refer to C422 Male or Female Terminal Replacement Procedure.

NOTE: Only replace the connector hard shell and/or a damaged pin terminal on the side the pushed out and/or damaged terminal(s) were found.
