N412NAS1

# TECHNICAL BULLETIN

SAFETY RECALL: Headliner Metal Plate Retention

MODEL:	MODEL YEAR:	VIN:
New Range Rover Evoque (LZ)	2020	000181-025797

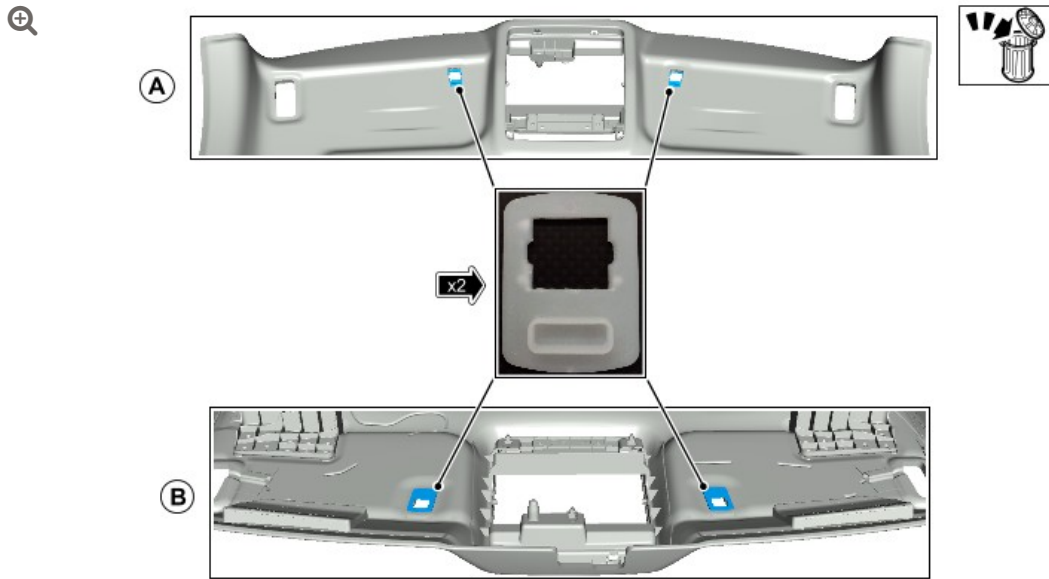
E257752

The headliner must be lowered for access; the 2 spacers shown must be removed and discarded.

- **A:** spacer location shown from beneath the headliner.
- **B:** spacer location from above the headliner.

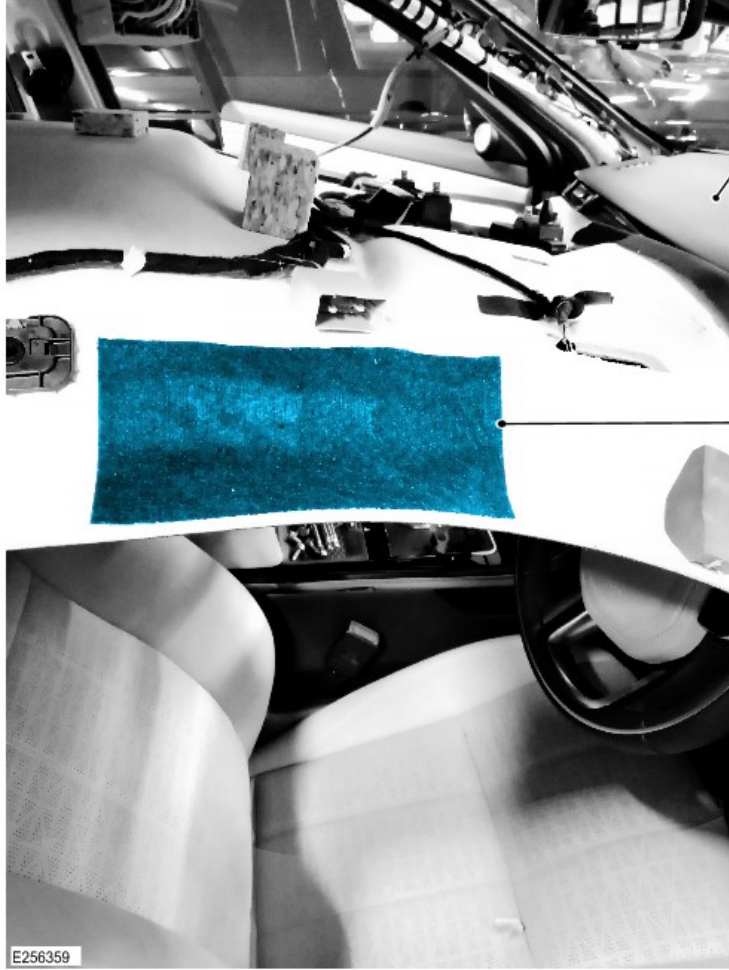
Note the area to be modified on both sides of the headliner.
