SIB 65 23 19

2020-04-23

RECALL 19V-851: DRIVER'S FRONT AIR BAG (NADI) INFLATOR

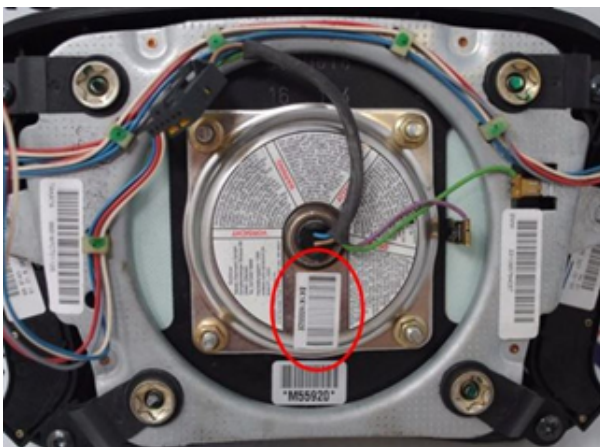
Basic Driver's air bag, showing the location of the parts label.

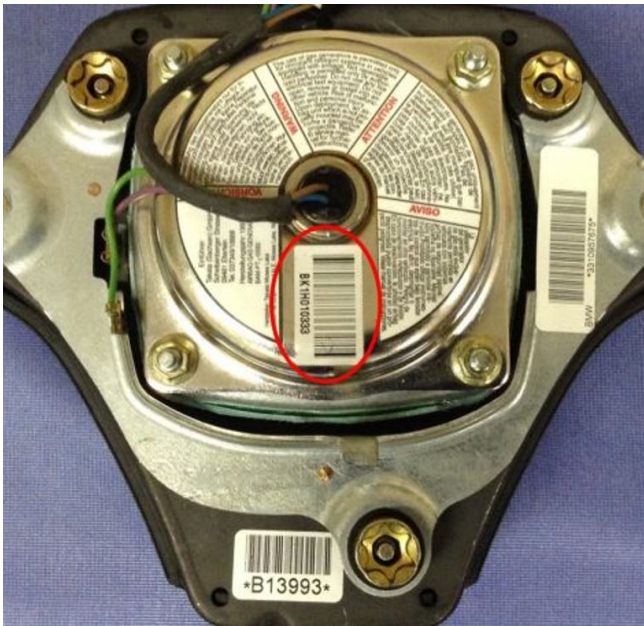
Sport Driver's air bag, showing the location of the parts label.

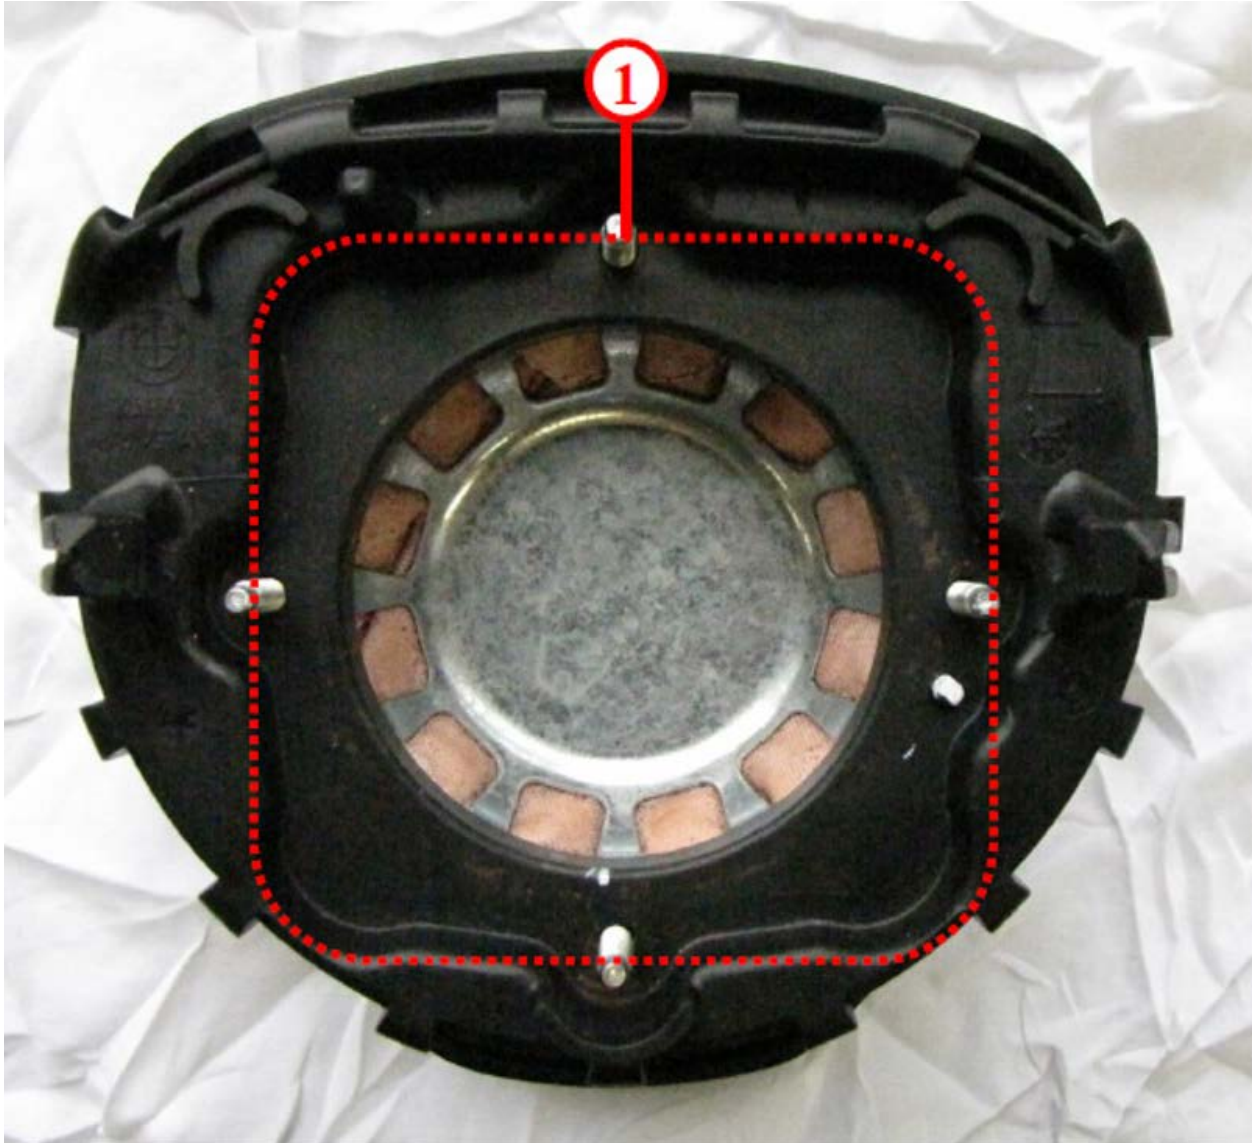
ATTENTION: In the area (1) above there must be no foreign objects!

There may be a small amount of surface rust on the metal within the air bag. This is normal.

Apply the four eyes principle and have this confirmed by two technicians.

- 1st Technician should perform a visual inspection of the air bag cavity for foreign objects.
- 2nd Technician should perform a visual inspection of the air bag cavity for foreign objects.

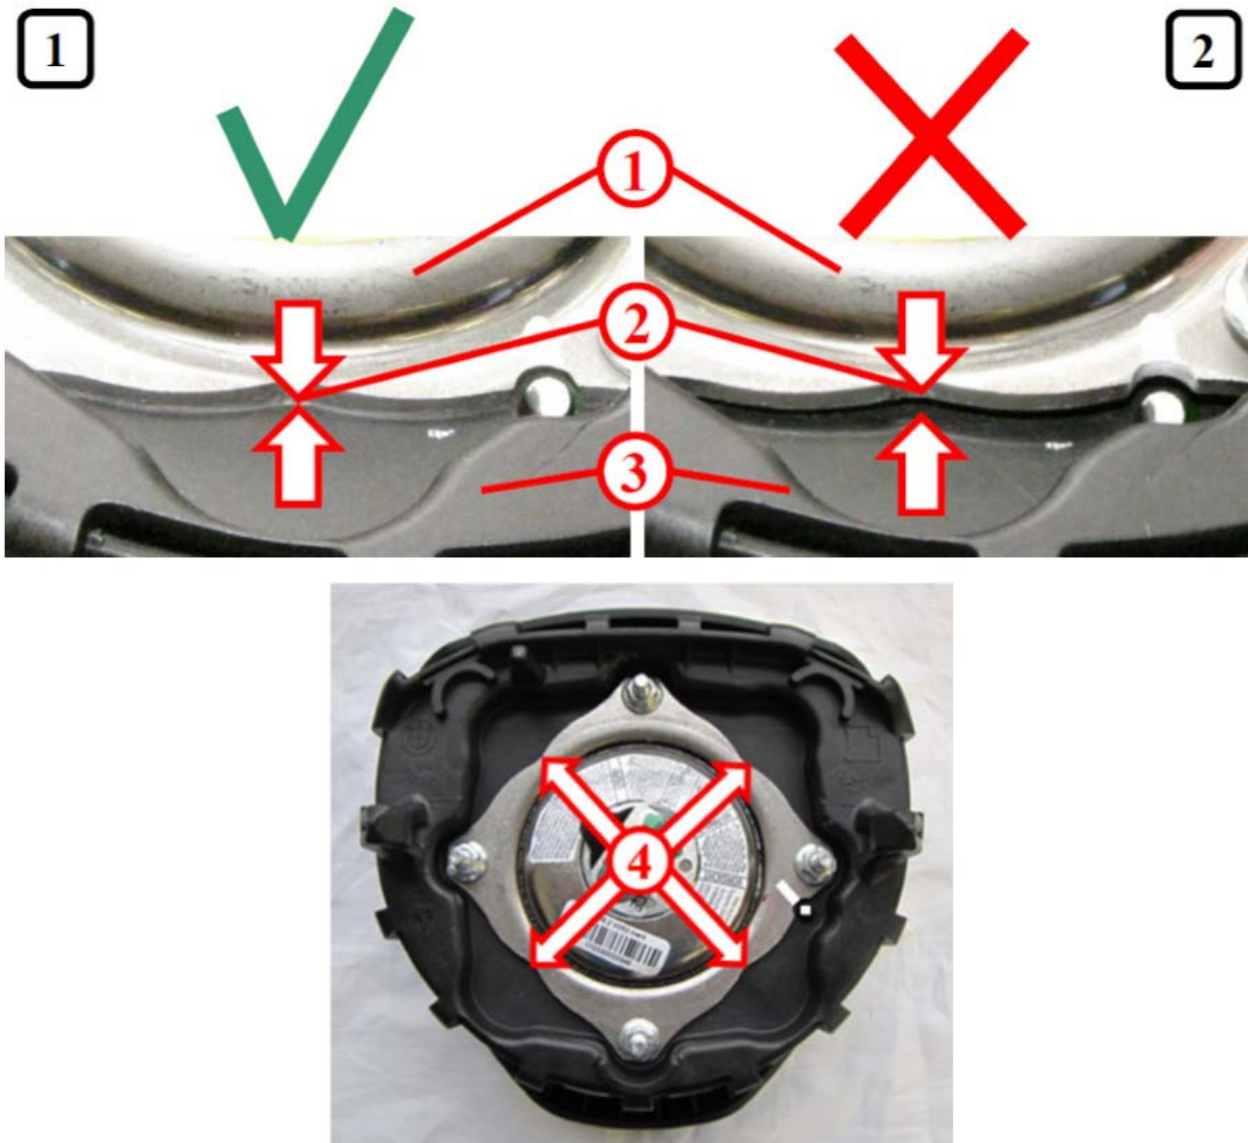
Perform a visual inspection of the gap (2) between the Generator (1) and the Air Bag (3) on all four sides of the Generator (4).

Picture (1) shows a correctly installed Generator

Picture (2) shows an improperly installed Generator with an excessive gap (2).

ATTENTION: If the gap cannot be closed up then cancel this procedure and replace the entire Air Bag assembly.
