SIB 65 25 19

RECALL 19V-853: DRIVER'S FRONT AIR BAG (NADI) INFLATOR

2020-01-31

E-Series	Model Description	Production Date
E46	3 Series Sedan, Coupe and Sportswagon	May 20, 1999 – July 14, 2000

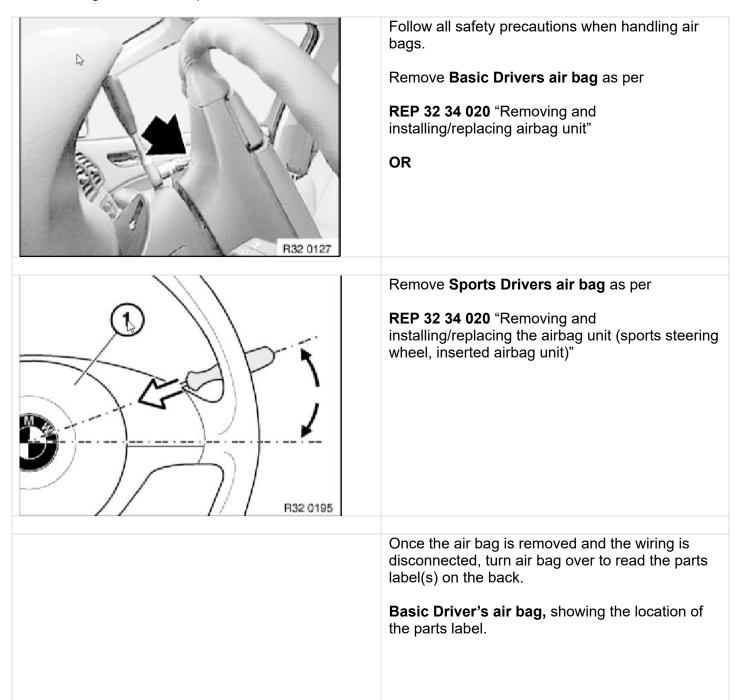
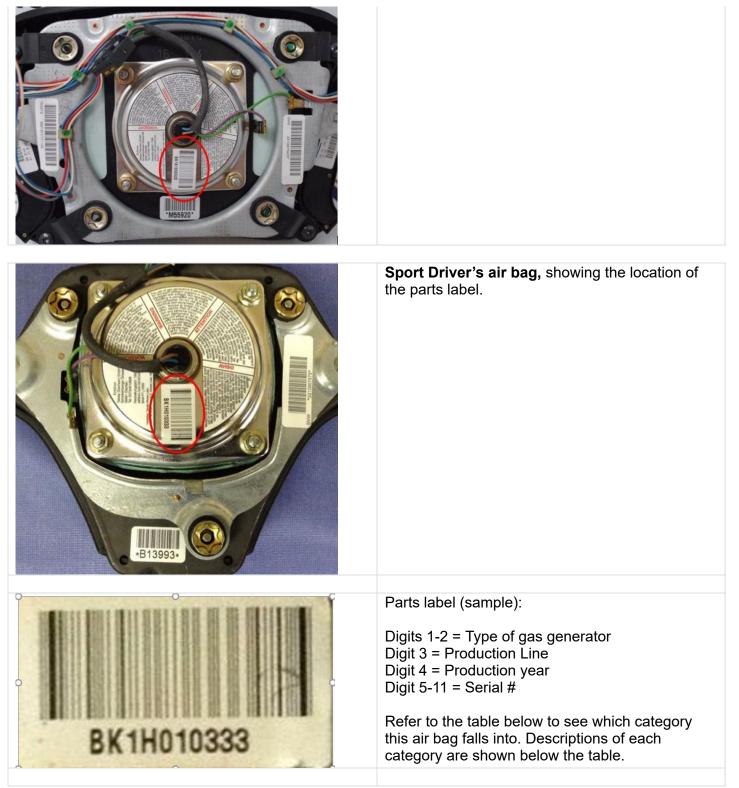
The following check can be performed at the customer's location:

Digits 1-3	Digit 4	Digit 5-11	Repair Category	
ВКС	н	ALL	Category 1 – Drivers air bag must be replaced; the vehicle cannot be driven until repaired.	
BKC	J	Up to	Category 1 – Drivers air bag must be replaced; the vehicle cannot	
Copyright ©2020 BMW of North America, Inc.

0596422	be driven until repaired.
BK1	н	ALL	Category 2 – Drivers air bag must be replaced once parts become available
BK1	J	ALL	Category 2 – Drivers air bag must be replaced once parts become available
BK1	К	Up to 0889843	Category 2 – Drivers air bag must be replaced once parts become available
BKC	J	From 059659A	Category 2 – Drivers air bag must be replaced once parts become available
BK1	К	From 0889922	Category 3 - Air bag is OK
BK1	L M N P Q R U V	ALL	Category 3 – Air bag is OK
BK5	-	ALL	Category 3 – Air bag is OK
BKV	-	ALL	Category 3 – Air bag is OK

If the serial number is not legible or the driver airbag / gas-generator (not type BK) cannot be identified, submit a TSARA case for support. Title the TSARA case **NADI TAKATA RECALL 19V-853.**

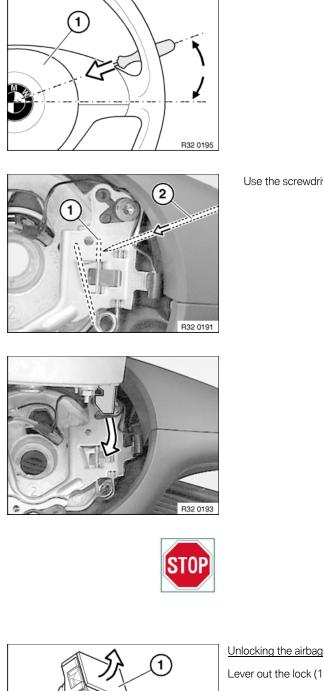
When installing a new airbag unit (see table below), the available ground spring (1) must be removed from the base plate of the steering wheel.

Omitting the ground spring (1) on new airbag units is not a safety hazard.

Insert a screwdriver through the opening on the rear side of the steering wheel and press on the lock. In the event of a spring resistance, press the lock up to the limit position and simultaneously pull away the airbag unit (1) from the steering wheel.

Repeat the process on the opposite side.
