December 6, 2019

Version 1

Safety Recall: 2019-20 CR-V Rear Subframe Bolts

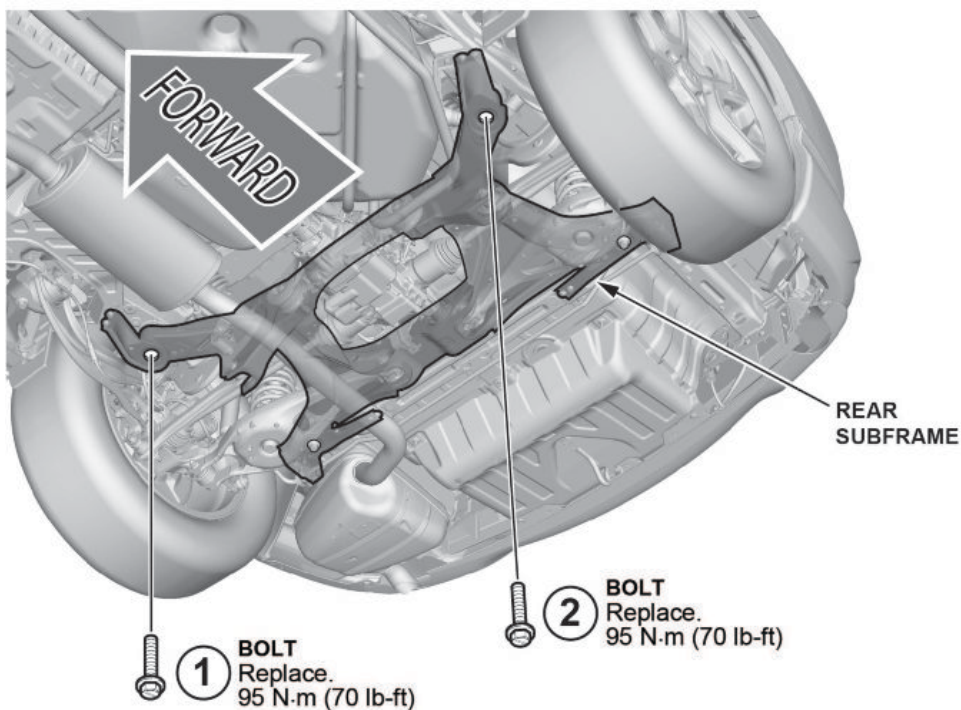
REPAIR PROCEDURE A (REPLACE TWO FRONT BOLTS ONLY)

There were some rear subframe bolts that were improperly manufactured without a wax solution. This will not allow the bolts to be secured properly when installed into the rear subframe, causing the bolts to possibly loosen, or fall off. If they loosen or fall off, the rear subframe may separate and may disable the vehicle, increasing the risk of a collision.

1. Mark both front bolts on the rear subframe with a red paint marker.
2. Remove the front right side bolt.
3. Install the new bolt, and torque it to **95 N·m (70 lb-ft)**. Make sure to mark the new bolt with a different color marker.

4. Repeat steps 2 and 3 for the other bolt.
5. Confirm that all four bolts on the rear subframe are torqued to **95 N·m (70 lb-ft)**.
