Safety Recall

Code: 34J6 – Interim Repair

Subject Mechatronic Accumulator Housing

Release Date November 24, 2020

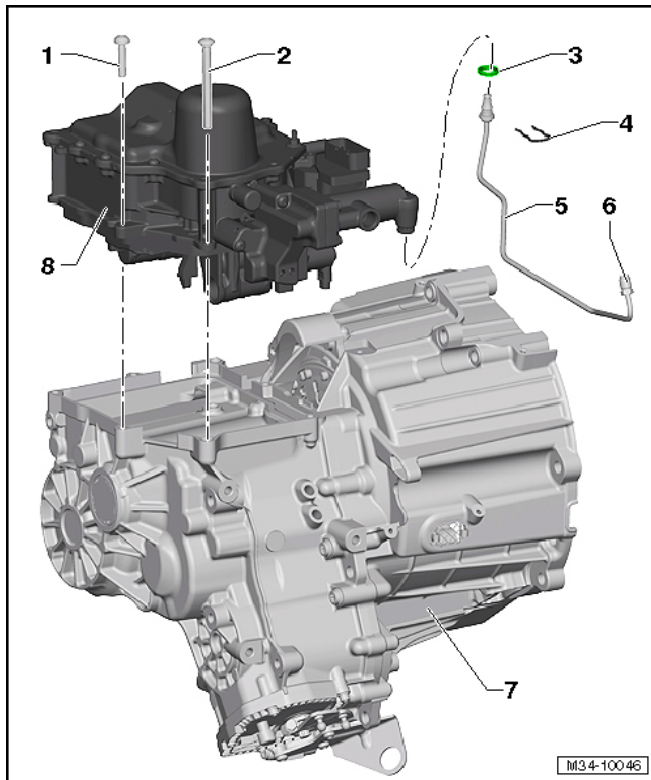
Section B – Evaluating TCM Faults

- Using GFF Diagnosis, check control unit 0002 for faults.
- If one or more of the following faults are set in control unit 0002: P17BF, P0841 or P189C
 - The mechatronic requires replacement.
 - Proceed to Section C.
- If additional faults are set in control unit 0002 and P17BF, P0841 or P189C are also set:
 - Contact Volkswagen Technical Assistance.
- If faults P17BF, P0841 or P189C are not present in control unit 0002:
 - No work can be performed under the campaign at this time.
 - The diagnosis and repair of faults will not be covered under this action.
 - No claim can be entered for this action at this time.
