TO: Mercedes-Benz Dealer Principals, General Managers, Sales Managers, Service Managers, Parts Managers	FROM: Gregory Gunther, Department Manager, Vehicle Compliance and Analysis, Engineering Services
RE: <b>Recall Campaign Launch Notification</b> <b>Replace Driver Airbag</b> <b>MY19 213 (E-Class)</b>	DATE: April 9, 2020

Campaign No. 2020030001, April 2020

SUBJECT: **Model E-Class AMG vehicles (213 platform)**  
**Model Year 2019**  
**Certification Driver Airbag (Airbag Replacement and Software Update)**

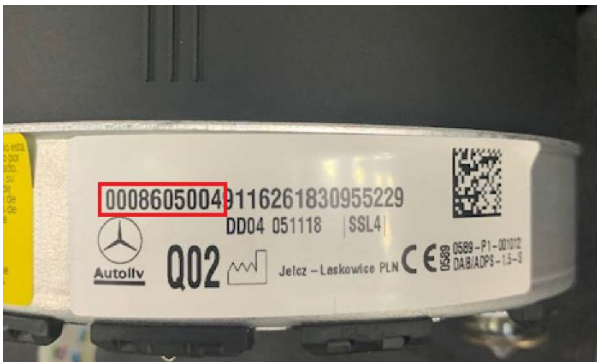
Figure 1

The part number can be found on the label on the airbag unit as shown in (figure 1, red box).

An airbag unit with the part number A 000 860 50 04 **must** be installed on the steering wheel.

A. Airbag unit with part number **A 000 860 50 04** installed on steering wheel:

Perform work procedure **B**.

B. Airbag unit with part number **A 000 860 50 04 NOT** installed on steering wheel:

Perform work procedures **A and B**.

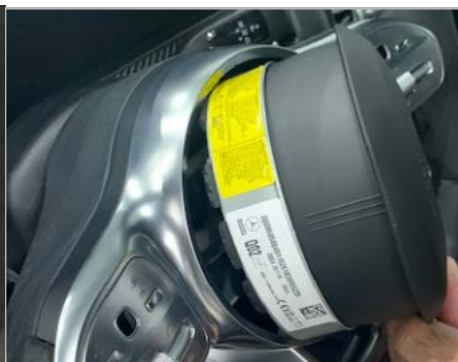
Figure 2

The part number can be read without disconnecting the airbag (figure 2).
