Mercedes-Benz

Campaign No. 2020030002, April 2020

SUBJECT: **Model E-Class AMG vehicles (213 platform)**  
**Model Year 2019**  
**Certification Driver Airbag (Airbag Replacement and Software Update)**

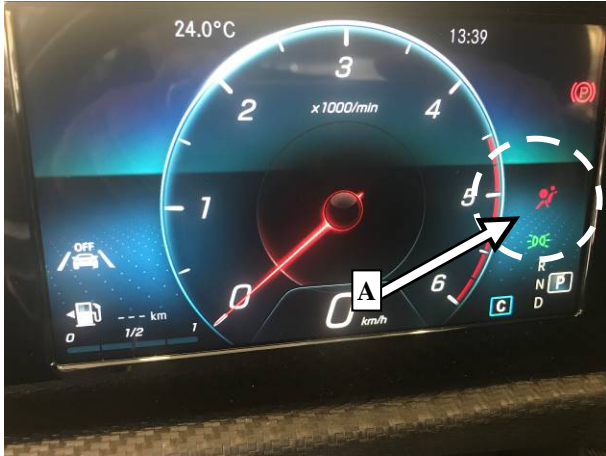
Figure 3

3. Switch ignition to position **1**. To do so, press start button once without touching the brake pedal. Check whether airbag indicator lamp (A, figure 1 **or** 2) permanently goes off after a few seconds.
