January 2020  
FL841A  
NHTSA #19V-869  
Transport Canada #2019-611

## Subject: FCCC School Bus Chassis Fan Clutch Bolts

**Models Affected: Specific Model Year 2020-2021 FCCC B2 school bus chassis (Thomas Built Buses Saf-T-Liner C2) manufactured January 21, 2019, through October 11, 2019, and equipped with a DD5 engine.**

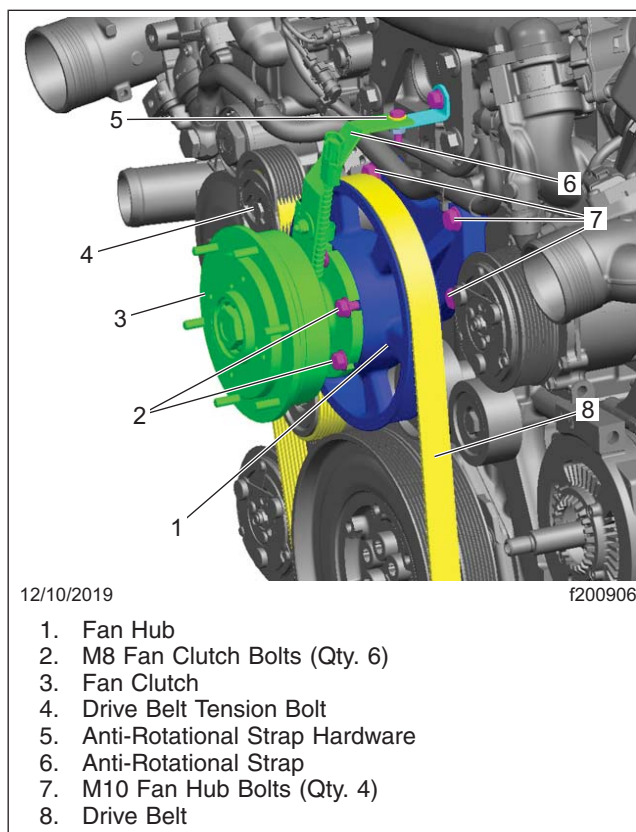
**Fig. 1, Fan Clutch Assembly**

On certain vehicles, the fan assembly bolts may have been improperly torqued. Improperly torqued fan assembly bolts may lead to the fan becoming loose, allowing the fan to contact surrounding components and potentially become detached from the engine. Noise from a loose fan assembly is expected to be very audible, and the school bus operator could be required to rapidly pull over with limited opportunity to identify a safe location, which could result in a disabled school bus and cause an evacuation in an uncontrolled traffic situation, increasing the risk of an injury.

1. Check the base label (Form WAR259) for a completion sticker for FL841 (Form WAR260) indicating this work has been done. The base label is usually located above the driver's window. If a sticker is present no work is needed. If there is no sticker, proceed with the next step.
2. Park the vehicle on a level surface, shut down the engine, and set the parking brake. Chock the tires.
3. Remove the six nuts that attach the fan blade assembly to the fan clutch and set the fan aside. Discard the nuts.
4. Disconnect the fan clutch connector.
5. Remove the bolt and nut from the anti-rotational strap and set aside. See [Fig. 1](#).
6. Loosen, but do not remove, the six fan clutch bolts. See [Fig. 1](#).

7. Using a long-handle ratchet and 15 mm socket, carefully push down on the drive belt tensioner and slide the belt off of the idler pulley.
8. Remove the six fan clutch bolts and set the fan clutch to the side.

9. In a criss-cross pattern, remove and replace the four fan hub bolts, one at a time. Tighten the new bolts  $35\pm4$  lbf·ft ( $47\pm5$  N·m).

10. Using new bolts, install the fan clutch.
  - 10.1 Ensure that the fan clutch is properly seated on the hub and that the new bolts are started and snug before tightening.

- 10.2 Using a long-handle ratchet and 15 mm socket, carefully push down on the drive belt tensioner and slide the belt over the idler pulley. Ensure that the drive belt is aligned on all pulleys; repeat as needed to properly align the drive belt.
  - 10.3 Tighten the bolts  $17\pm2$  lbf·ft ( $23\pm3$  N·m).
11. Using the hardware removed earlier, install the anti-rotational strap. Tighten the bolt 60 lbf·in (678 N·cm).
12. Connect the fan clutch connector.
13. Using new hardware, install the fan blade assembly. Tighten the nuts 19 lbf·ft (26 N·cm) in a diagonal pattern.
14. Start the engine and listen for any unusual noise. Look at the drive belt and ensure it is properly aligned.
15. Clean a spot on the base label (Form WAR259). Write the recall number, FL841, on a blank completion sticker (Form WAR260), and attach it to the base label to indicate this recall has been completed.
