Roof Ladder May Interfere with Egress Window

Bulletin Type:	Safety Recall	Publication Date:	December 2019
Bulletin #:	19V-873 US 2019-615 Canada	Make:	Jayco
Job Code:	9901503	Model:	White Hawk 24MBH
Flat Rate:	RC024 Inspection ONLY .2 Hr. RC025 Inspect, fiberglass Repair, relocate ladder 6 Hr. RC026 Transport time to/from body shop – when Dealer is NOT performing the fiberglass repair 1 Hr.	Model Year:	2019-2020

Incident:	Emergency exit window may not open fully due to placement of ladder.
Affected Units:	2019 White Hawk 24MBH K1440256-0281 2020 White Hawk 24MBH L1440051-0080
Misc. Tools & Supplies:	Screw gun with long #2 square drive bit Putty stick Tape Measure Ladder Caulk gun 1 tube of 502 LSD self-leveling sealant

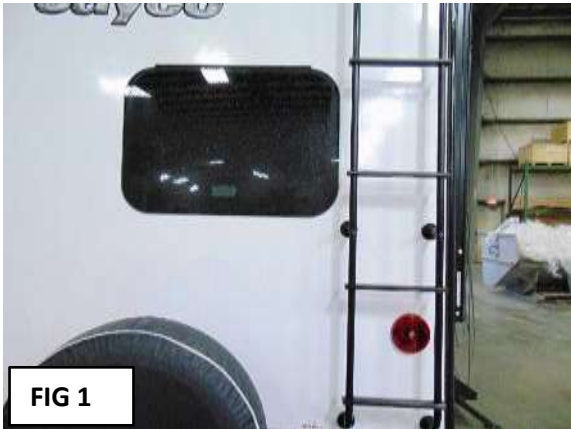
FIG 1:

- Inspect the ladder position in relation to the egress window.

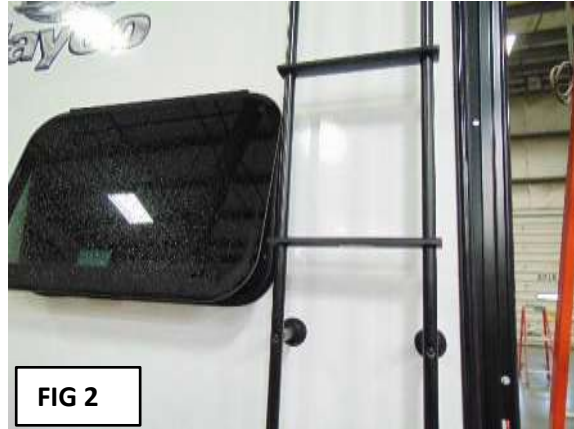
FIG 2:

- **CAREFULLY** Open the egress window to determine if it clears the ladder.
- If the window opens FULLY, without any interference with the roof ladder, no further action is necessary.
- If the window does not open FULLY due to the ladder placement, continue with the repair outlined below.

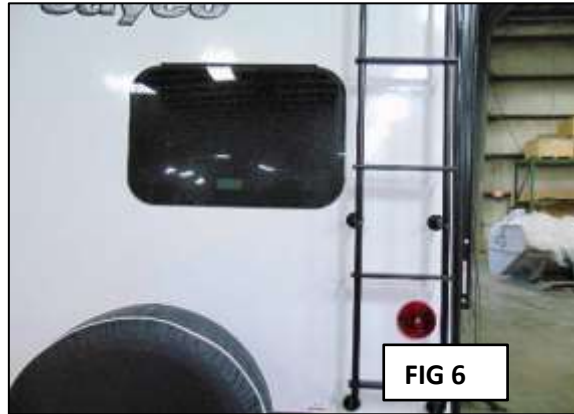
FIG 6:

- Shows ladder installation with proper clearance to open the egress window.
