TO: Mercedes-Benz Dealer Principals, General Managers, Sales Managers, Service Managers, Parts Managers	FROM: Anthony Washington, Department Manager, Regulations and Certifications
RE: Recall Campaign Notification Model 907 (Sprinter) Model Years 2019 Lashing Rails	DATE: April 1, 2020

Campaign No. 2020020018, March 2020

SUBJECT: **Model 907 (Sprinter), Model Year 2019**
Tie-down Rails

Order No. V-RC- 2020020018

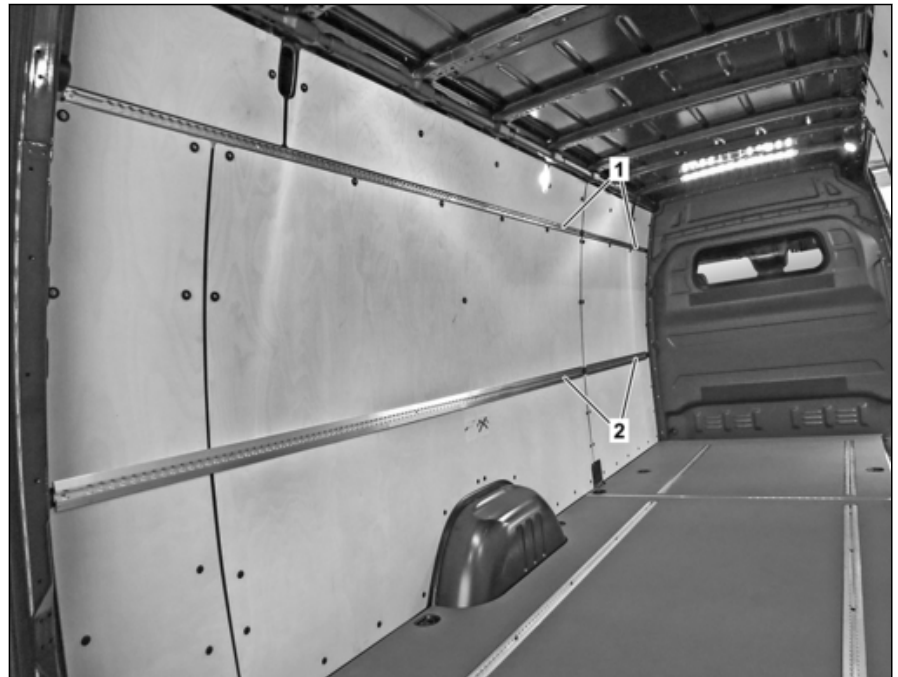
D68.50-A025-06

Shown on model 907.6 with code VA2 (load compartment interior trim up to roof height (wood))

- 1 Tie-down rail
- 2 Tie-down rail

Remove		
2	Remove all load compartment trim between tie-down rails (1) at the top and tie-down rails (2) at the center.	Model 907.6 with code VC4 (Tie-down rails on side wall to roof frame)	AR68.30-D-1185TS

3	Drill out rivets of all installed tie-down rails (1, 2).

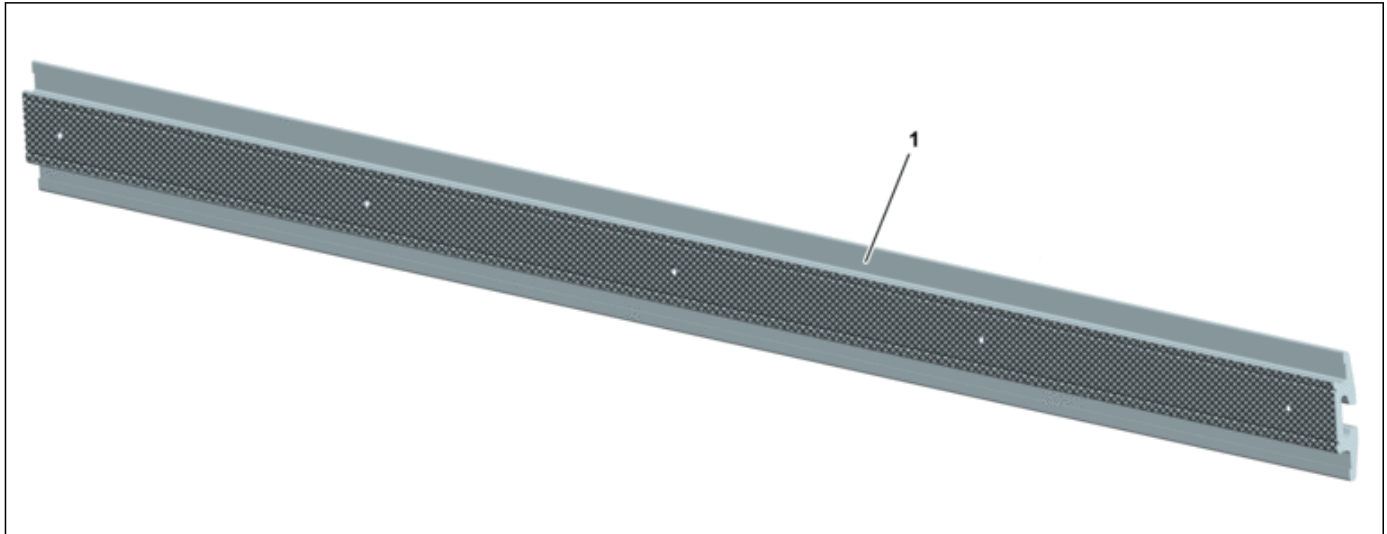
D68.50-1161-78

Shown on tie-down rail (1) with code V42 (Side wall to belt rail tie-down rails)

1 Tie-down rail

Install		
9	Remove adhesive residue from tie-down rails (1, 2) using a suitable tool and grind mating surfaces in crosshatched areas.

12	Apply adhesive to tie-down rails (1, 2).	<p>
