PRODUCT CAMPAIGN BULLETIN

APPLICABILITY: 2016-2017MY Outback **NUMBER:** WUX-09
SUBJECT: 2016-2017 Outback Replacement **NHTSA ID:** 19V910
 Airbag Control Module **DATE:** 01/02/20

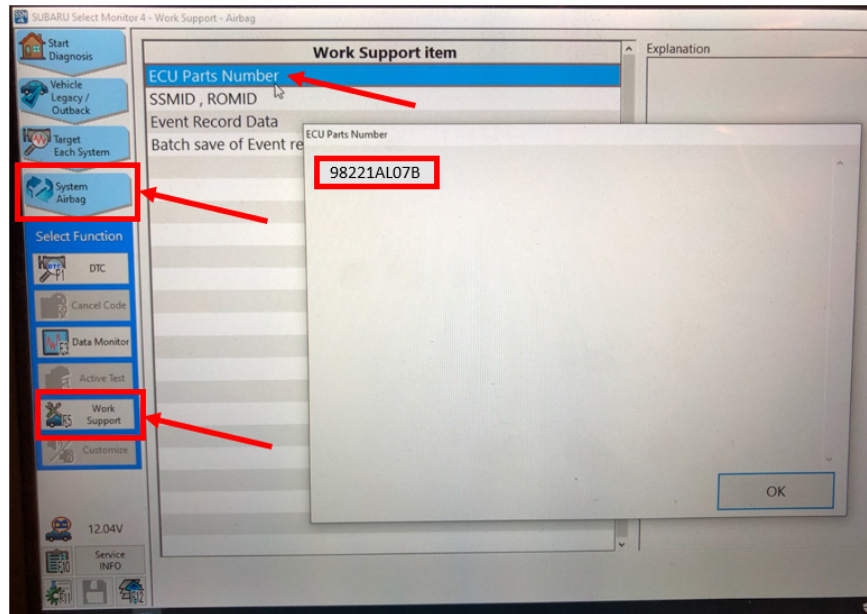
Step 1: Inspection: Using the Select Monitor, select: Each System > Airbag > Work Support > ECU Parts Number, to confirm the part number of the currently installed Airbag Control Module as shown below.

- If the Part Number is **98221AL07B**, proceed to **Step 2**.
- If the part number is **NOT 98221AL07B**, the vehicle is **NOT AFFECTED** by this recall. **IMPORTANT:** Record the ECU part number on the repair order as this will be required for claim submission. Proceed to the CLAIM REIMBURSEMENT AND ENTRY PROCEDURES section and process a claim for **Inspection Only**.

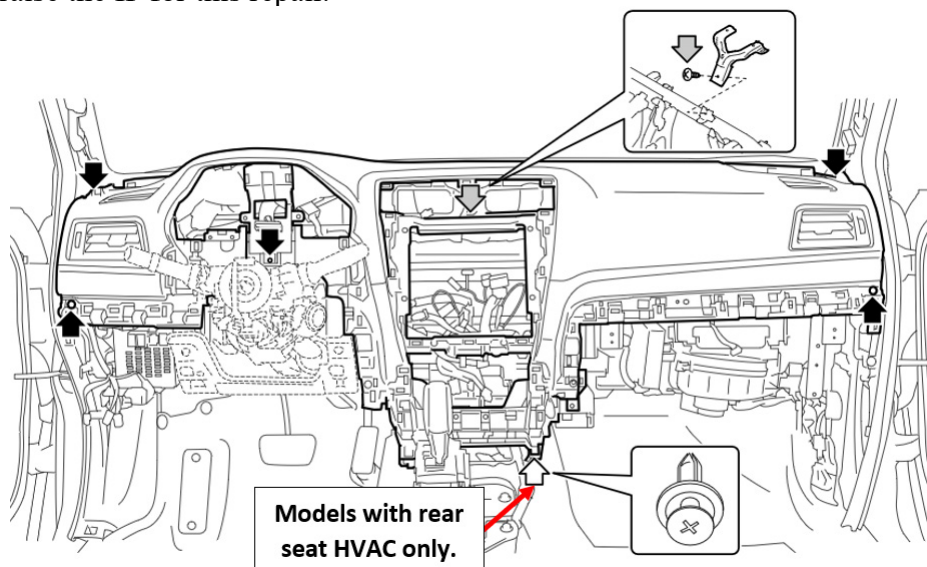
Step 2: The Service Procedure for replacing the passenger's side front airbag module utilizes the currently applicable Service Manual steps (excluding Step 2, seat removal) up to and including Step 16. At that point, the instrument panel (IP) should be loosened but **NOT** removed. The illustration below shows locations of the IP retaining screws. All these screws must be removed before attempting to raise the IP for this repair.

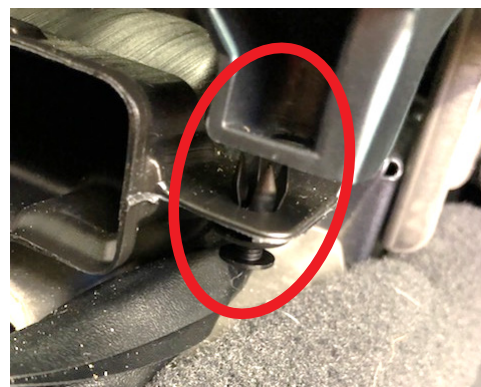
NOTE: On models with rear seat HVAC (air vents on the back of the console box), in addition to an air duct running past the shifter, there is a clip under the storage box on the right side at the base of the IP securing the rear seat area ventilation duct which must be removed. Models without rear seat HVAC do not have this clip or the air ducts.

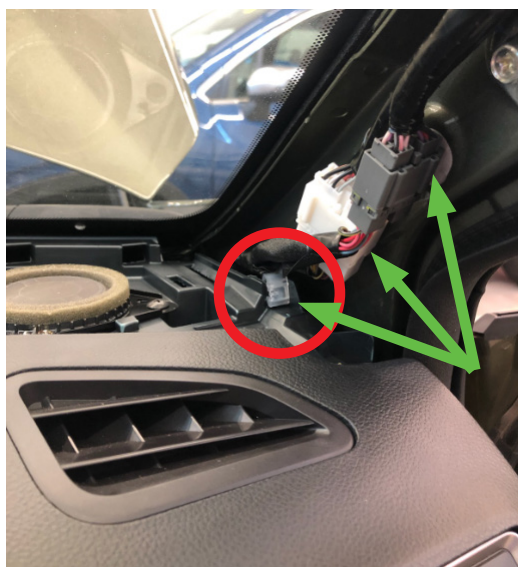
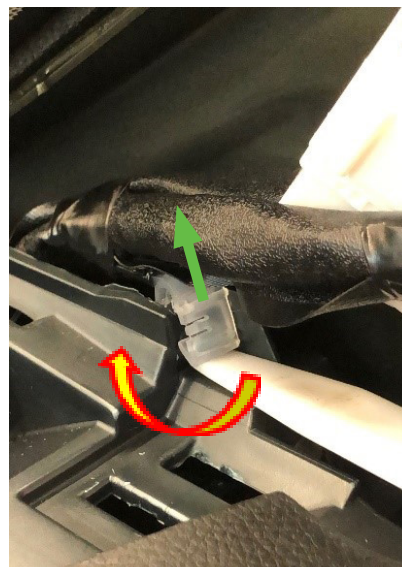
- **CAREFULLY** remove both “A” pillar trims with a plastic trim tool and disengage the tether clips at the top of each panel. After removing the IP speaker grille, twist / disengage the retaining clip for the wiring harness from the IP as shown in the photos below. Use a trim clip removal tool to disengage the retaining clips for the 2 harness connectors secured to the “A” pillar.

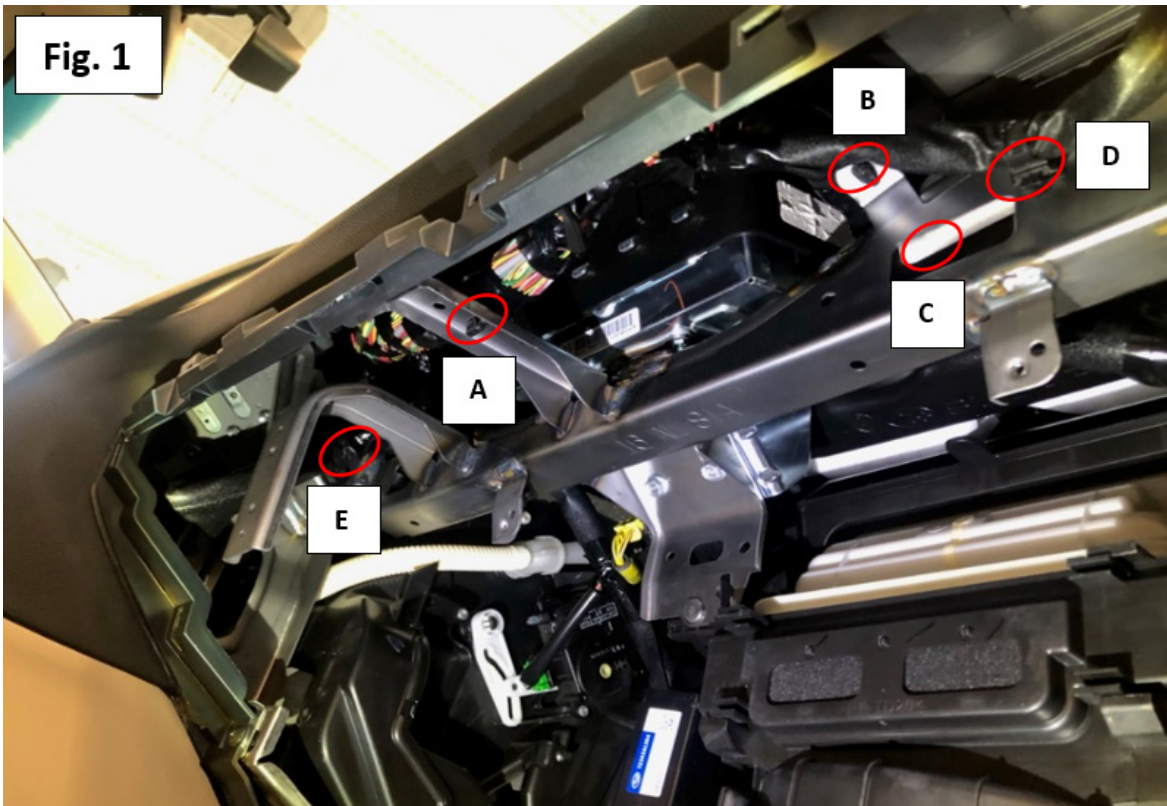
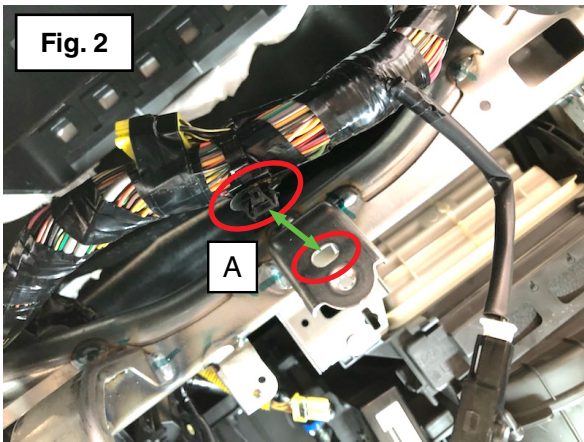
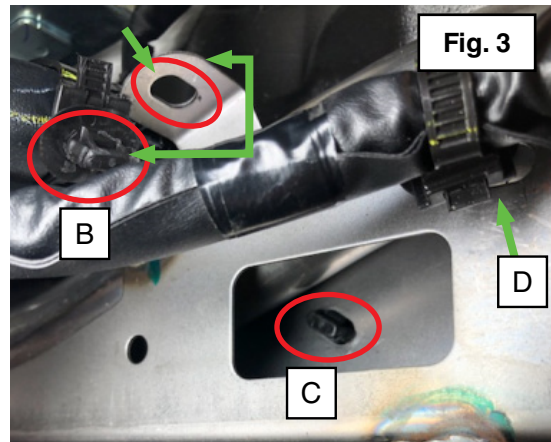
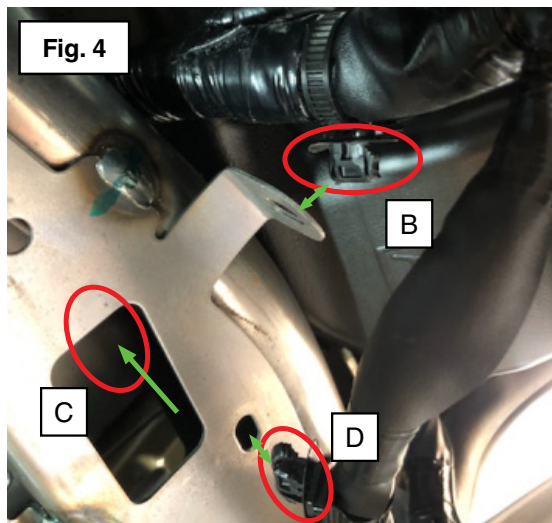
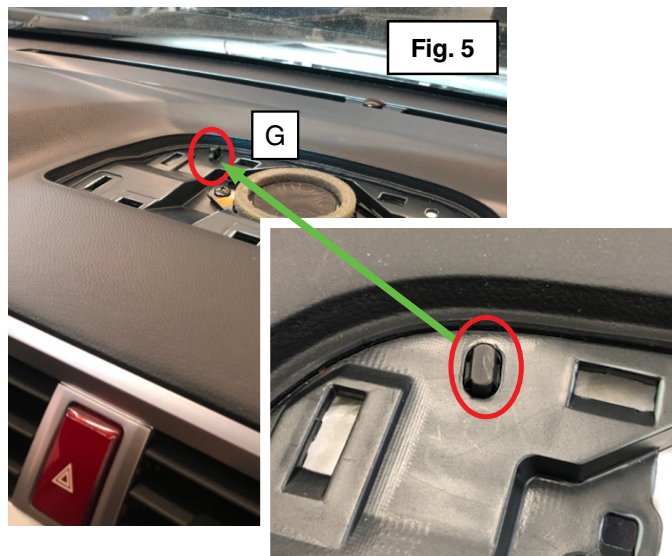
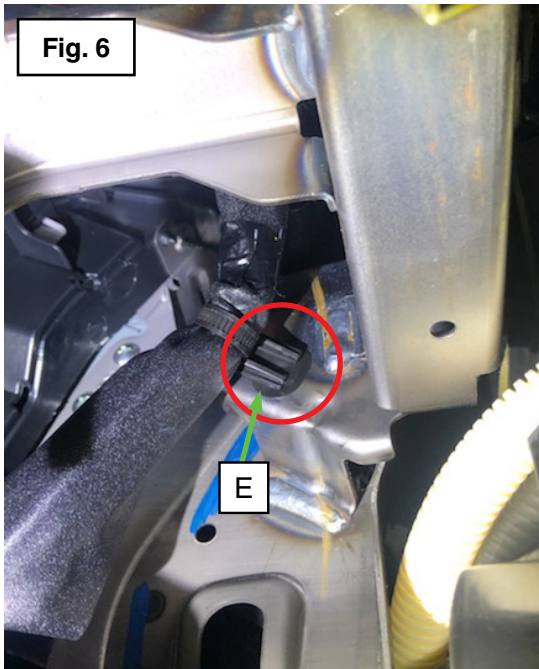
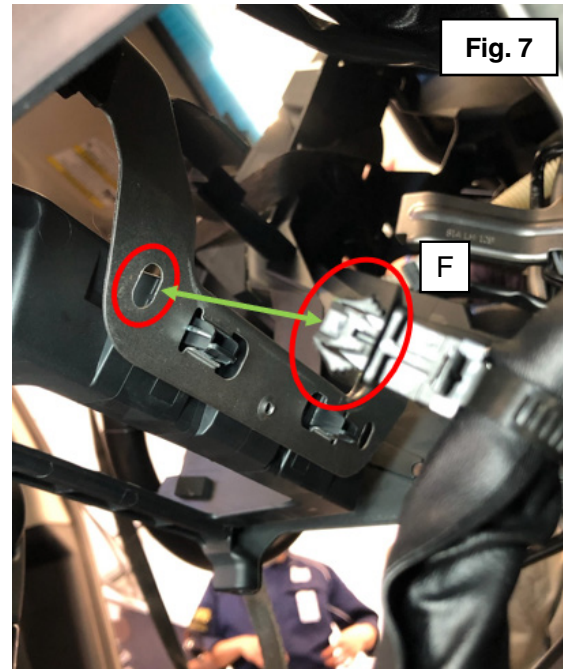
- **CAREFULLY** release the plastic retaining clips securing the IP wiring harness in the 7 locations shown below using a needle-nosed plier or trim clip removal tool. Use the overall photo (Fig. 1) shown below for clip location reference and the rest of the photos for specifics. Releasing these clips provides additional access to get the airbag module past the harness. Fig. 2 shows clip A on a brace adjacent to the airbag module. Figs. 3 and 4 show the same clips (B, C & D) but the photos were taken from different angles.

Fig. 5 shows clip G under the IP top center speaker grille. Figs. 6 & 7 show clips E & F securing the harness to braces in the center of the IP near the storage box below the audio unit and HVAC controls.

IMPORTANT NOTE: Since clip D is not accessible from behind to release it and will most likely be damaged during removal, a replacement is included in the box along with the new replacement airbag module.

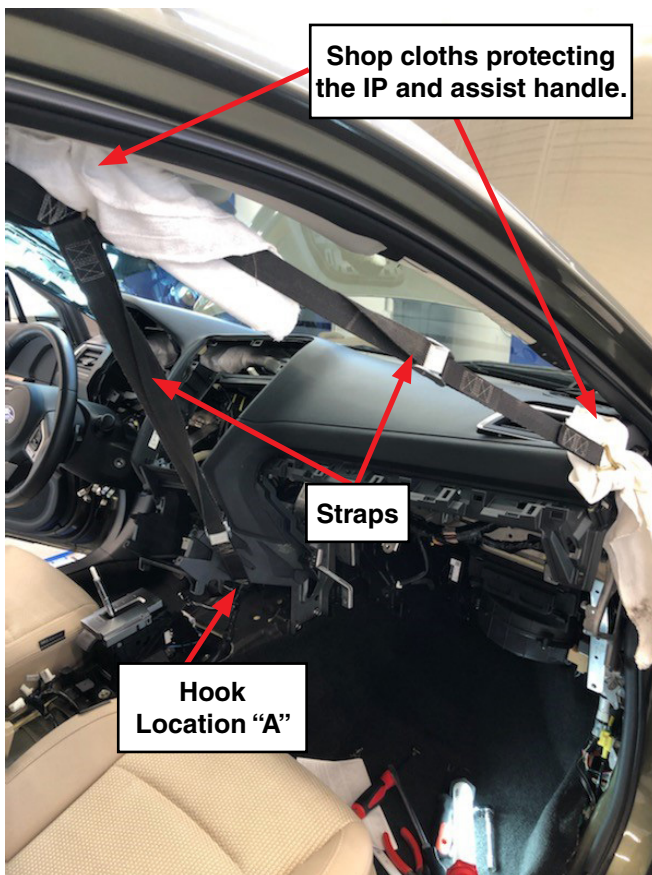
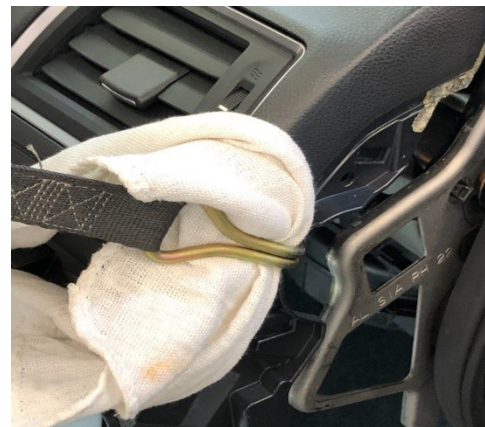
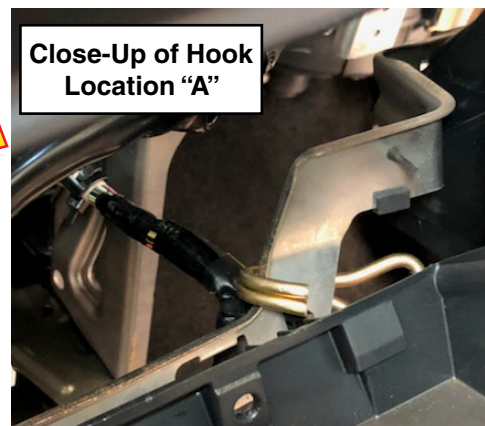
The procedure shown below utilizes 2 generic, readily available tie-down straps in place between the IP and the passenger assist handle to hold the right side of the IP elevated while removing and reinstalling the airbag module.

VERY IMPORTANT: Always protect the IP and assist handle from the strap hooks with clean shop cloths (or equivalent). Recommended positions for the hooks are shown in the photos below. Hook location “A” is on the right side of a metal IP support bracket near the center storage box.
