Subject: Tag Axle Lock Clamps Rework			
Field Change Program: Field Campaign	FCP Number: 477	Revision: A	Date: 02/18/2020
Coach Section: 12- Suspension	P/N: 12-04-1253		Type: Safety Recall

Ref. NHTSA Recall No.: 19V-924	Ref. Transport Canada Recall No.: N/A
--	---

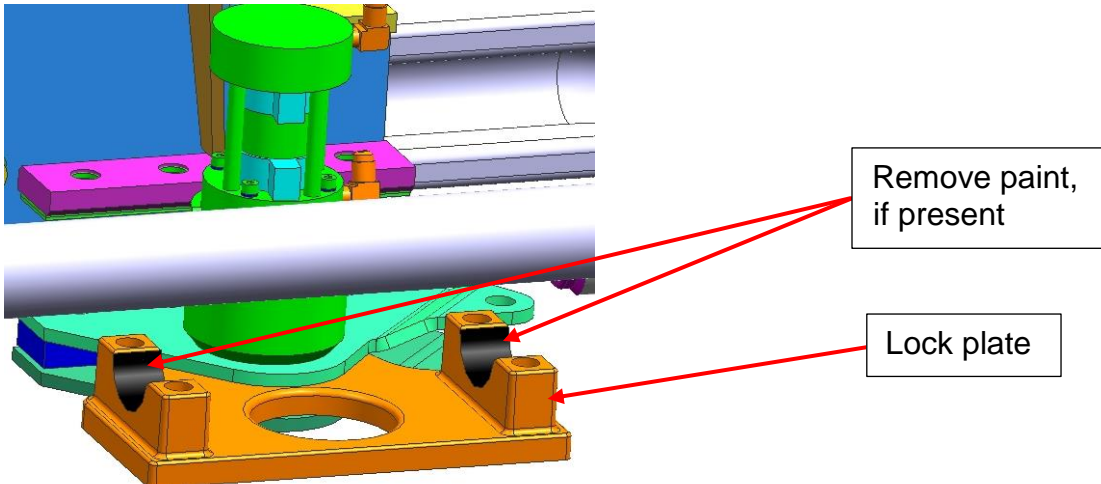
The causes of the insufficient clamping were determined to be (1) the clamp blocks having paint on the clamping surfaces, (2) the fastener surfaces on the clamp blocks not being machined, and (3) the fastener head surface not being perpendicular to the tie rod clamping surface. The combination of paint on the clamping surface and the fastener head side loading allowed the clamp fasteners to lose torque. This allowed the tie rod to slide in operation when under load. Movement of the tie rod within the lock clamps allowed the tag axle to be offset from the front steering axle.

Slide the lock assembly and lock plate down and observe for paint on the lock plate at the location illustrated below. If paint is observed on the surface of the lock plate that clamps the tie rod, use an abrasive paper to remove the paint in that area.
