IMMEDIATE ACTION REQUIRED: Vector 8611MT Multi-Temperature Trailer Refrigeration Unit

SER20-013
04/22/2020

SUBJECT: REQUIRED Vector™ 8611MT Generator Harness Inspection & Routing Correction

VECTOR™ 8611MT GENERATOR HARNESS INSPECTION & ROUTING CORRECTION

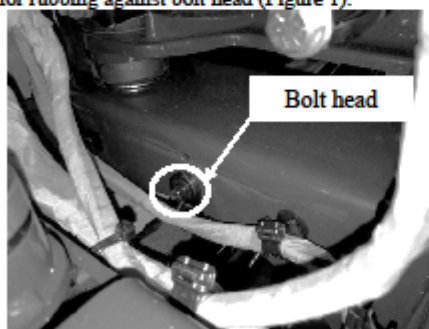
Figure 1

1. Inspect the generator high voltage wiring harness for rubbing against bolt head (Figure 1).

3. If the tape is not abraded to the point that wires can be seen, skip to step 7.
4. If there is abrasion to the tape or wiring insulation, but the wire insulation is not compromised, (no copper showing), skip to step 6.
5. If any of the wires have copper conductors visible, remove the cloth tape for access and cut the wire at the damage. Repair using a butt splice and two layers of heat shrink over the butt splice (1/4" and ½") per Vector Ops & Service Manual 62-11640 page 8-54.

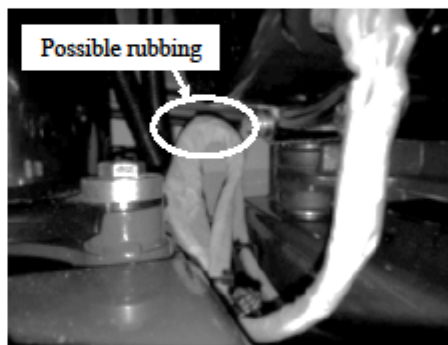
Figure 2

2. Inspect generator high voltage wiring harness for rubbing against generator (Figure 2).
