Supplemental Information for Equipment Report -- 20E-057

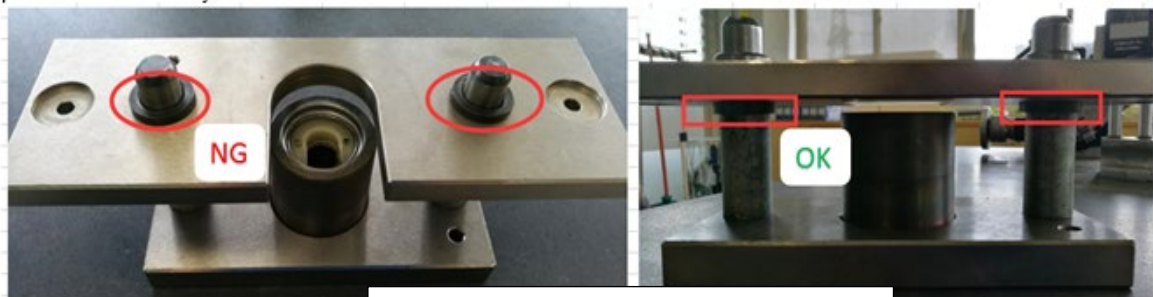
The operator mistakenly reverse crimping fixture during production, so the tool can't limit the fixture's position. The operator didn't increase pressure on crimping fixture for 2 sec. according to SOP so the crimping is not processed correctly.

WHY1: Crimping machine did not put enough pressure on casting to secure seal properly.

WHY2: Process operator reversed the crimping fixture which caused the tool to limit the crimping angle and pressure.

WHY3: The SOP was not followed correctly and controls were not adjusted to include two seconds of applied pressure.

WHY4: The sum of tolerances between the casting and plastic seal, plus the lack of controls to lock the plastic seal during assembly can lead to improper crimping, allowing the seal to move.

WHY5: The master cylinder design does not consider an error proofing solution to secure the seal regardless of assembly and operator mistakes.
