**September 18, 2020**

## Safety Recall: 2017–20 Ridgeline Accessory Tonneau Cover Attachment Information

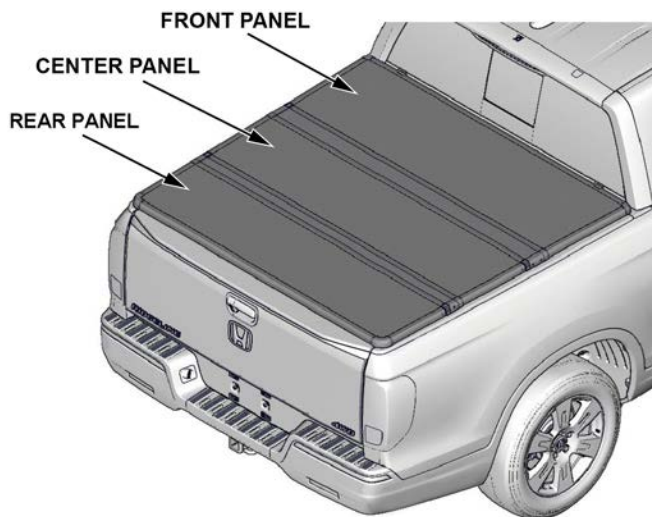
1. Make sure the vehicle has a Honda Genuine accessory tonneau cover, and it does not have the updated tether kit and warning labels installed.

- If it is a Honda Genuine accessory tonneau cover, and it does not have the updated tether kit and warning labels, go to REPAIR PROCEDURE.
- If the vehicle is not equipped with a Honda Genuine accessory tonneau cover, or it already has the updated tether kit and warning labels, submit a Campaign Status Change Request Form to the Campaign department. E-mail it to [campaign\\_change\\_request@ahm.honda.com](mailto:campaign_change_request@ahm.honda.com), or FAX it to **310-781-4823**.
