**October 21, 2020**

## Safety Recall: 2017–20 Ridgeline Accessory Tonneau Cover Attachment Information

Supersedes 20-057, dated September 18, 2020, to revise the information highlighted in **yellow**

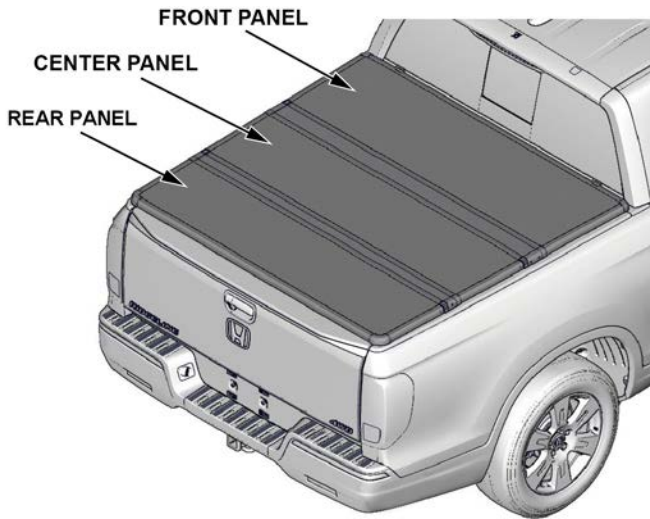
1. Make sure the vehicle has a Honda Genuine accessory tonneau cover, and it does not have the updated tether kit and warning labels installed.

- If it is a Honda Genuine accessory tonneau cover, and it does not have the updated tether kit and warning labels, go to REPAIR PROCEDURE.
- If the vehicle is not equipped with a Honda Genuine accessory tonneau cover, or it already has the updated tether kit and warning labels, submit a Campaign Status Change Request Form to the Campaign department. E-mail it to [campaign\\_change\\_request@ahm.honda.com](mailto:campaign_change_request@ahm.honda.com), or FAX it to **310-781-4823**.
