Recall Service Bulletin

RSB20-560-001

APPLIES TO: This Recall Service Bulletin applies to Spartan Fire, LLC Model Year 2012-2016 Gladiator and Metro Star cab-chassis built between August 8, 2012, and October 11, 2016. Vehicles affected are limited only to cab-chassis equipped with Spartan Advanced Protection System that have had a replacement instrument panel S-2708-001 installed.

CONDITION: Advanced Protection System may not be operable after replacement of original instrument panel with kit S-2708-001.

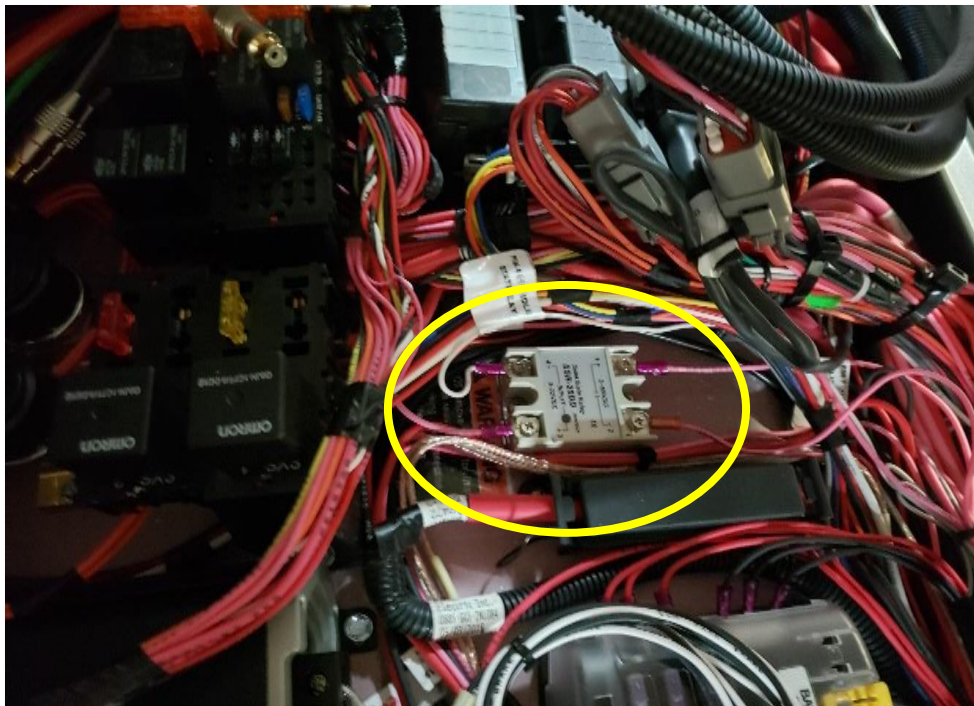
FIG 2-1

1. Crimp the 2 eyelets (0636-GG5-A08) on each end of the pink wire (0740-GG5-A08) provided with the kit.
2. Locate the solid-state relay in the center switch console, as shown in FIG 2-1.

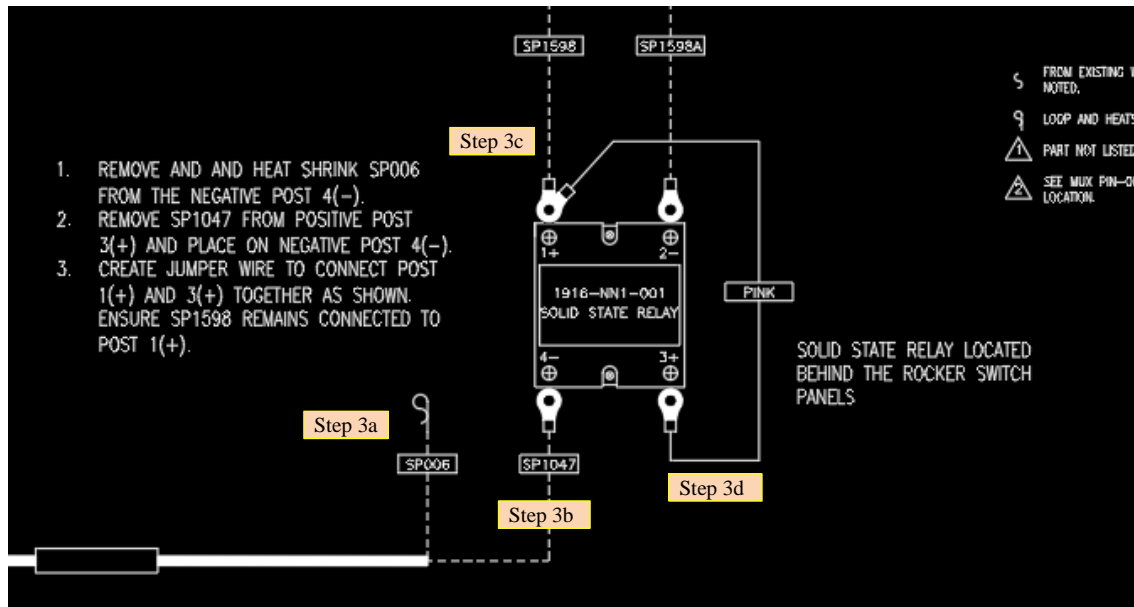
FIG 3-1

3. Use the provided diagram 0221-GG9-3471 to rework the circuits connected to the solid-state relay, as shown in FIG 3-1:

- Remove SP006 from Post 4(-) and protect the end of the wire.
- Remove SP1047 from the Post 3(+) and place on Post 4(-)
- Connect the pink wire created in step 1 to Post 1(+), leaving current wire SP1598 connected.
- Connect the other end of the pink wire to post 3(+).

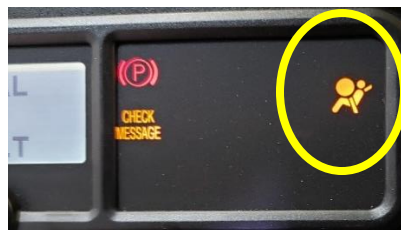
FIG 3-2

- Once all electrical connections are made, turn master and ignition switches to the ON position and start the vehicle
- Verify the Advanced Protection System (APS) icon in the Lightbar/Message Center (LMC) flashes shortly after the engine starts. The icon will flash 6 to 8 times before turning off. The flashing icon indicates the APS control module is active and completing a power-on self-test cycle. If no faults are detected at startup, the light is extinguished.
