IMPORTANT SAFETY RECALL

NHTSA RECALL NO. 20E091

December 2020

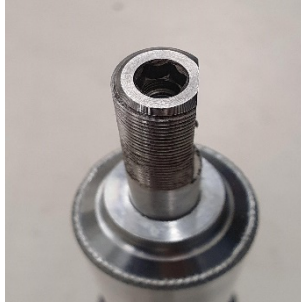
Due to a design compatibility issue related to the interface between the vehicle's top mount and the strut, the pin of the strut may experience excessive stress during maximum steering, which can lead to fatigue and, potentially, breakage of the pin. If the pin fails, it will result in the separation of the strut from the vehicle and compromise front-wheel control, increasing the risk of a vehicle crash.

Recalled Part no marking

- (1) Inspect the customer's front struts to confirm that they are covered by this recall. Only POS 5N20 struts without the markings should be replaced;
- (2) If the product is covered, arrange to have the strut replaced with a new Öhlins front strut, Part No. POS 5N20 or POS 5N21, and the new OE / top mount interface solution, all included in a recall kit that will be provided by Öhlins, at no cost to the customer;
- (3) Submit a claim under the Öhlins warranty claims process and according to instructions included in the recall kit.

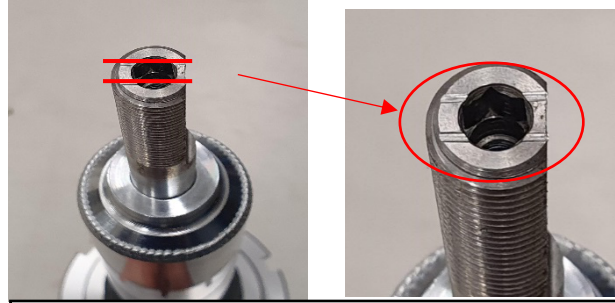
Replacement product is identified by two parallel marks on top of the pin, visible from the engine compartment in the installed position.
