Safety Recall Action Notice 570 Issue 1 - 01.2020

Subject: Side Stand Spring Replace				
Notice Number	Models Affected	VIN Range		Markets Affected
570	Thrupton 1200, Thrupton 1200 (Dual Seat), Thrupton 1200R, Thrupton 1200R (Dual Seat), Thrupton TFC	From	740405	All markets
		Up to	959980

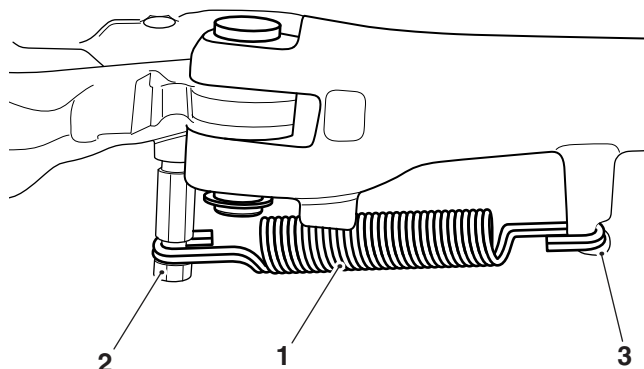
Internal investigations have identified a need to replace the side stand spring on the above models. Dealers are requested to replace the side stand spring as described in the instructions below.

- Side stand spring (to be replaced)**
- Retainer peg**
- Side stand lug**

- With the side stand in its retracted position as shown below, unhook the spring from the side stand noting the spring hook orientation, and remove it from the motorcycle.

- In the same orientation as the original spring, hook the new side stand spring and rubber sleeve onto its retainer peg then carefully hook it onto the side stand lug. Do not remove the rubber sleeve.
- Check the operation of the side stand. Ensure the spring holds the stand securely in the retracted position.
- Lower the motorcycle to the ground and park it on the side stand.
