SIB 65 02 20

RECALL CAMPAIGN 20V-016: REPLACE PASSENGER'S FRONT AIR BAG MODULE 2020-01-16

RE: Recall 20V-016: Replace Passenger's Front Air Bag Module – B65 02 20

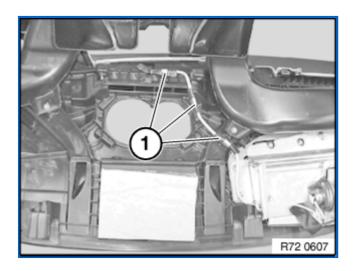
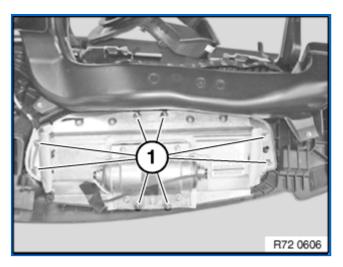
Unclip airbag lead with holders (1) from instrument panel.

Unscrew nuts (1). *Installation:* Replace nuts.

Tightening torque <u>72 12 01AZ</u>.

Remove airbag module from instrument panel.
