Subject: 3 New Takata Recalls (Effective Today, January 16, 2020)

SIB 65 01 20

RECALL CAMPAIGN 20V-018: REPLACE PASSENGER'S FRONT AIR BAG MODULE

RE: Recall 20V-018: Replace Passenger's Front Air Bag Module – B65 01 20

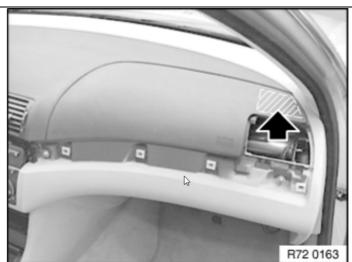
• Position of the retaining clip of the front passenger's airbag cover
