SIB 65 01 20

RECALL CAMPAIGN 20V-018: REPLACE PASSENGER'S FRONT AIR BAG MODULE

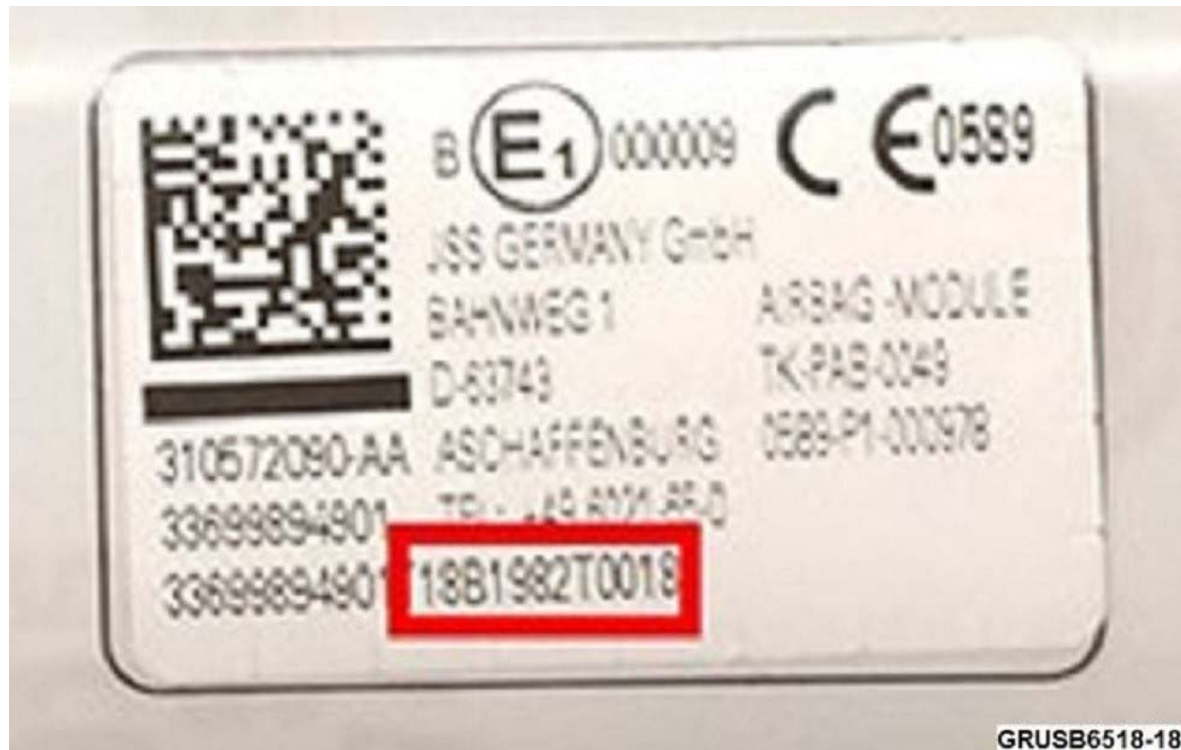
Access front passenger air bag to read the parts label.

- If it is a final repair air bag (part number 72 12 6 998 949), no further action is necessary and this recall can be closed.
- If it is any other part number, perform the Recall repair.
