SIB 65 01 20

RECALL CAMPAIGN 20V-018: REPLACE PASSENGER'S FRONT AIR BAG MODULE

E-Series	Model Description	Model Years	Production Dates
E46	3 Series	2000 to 2006	February 25, 1999 – August 28, 2006

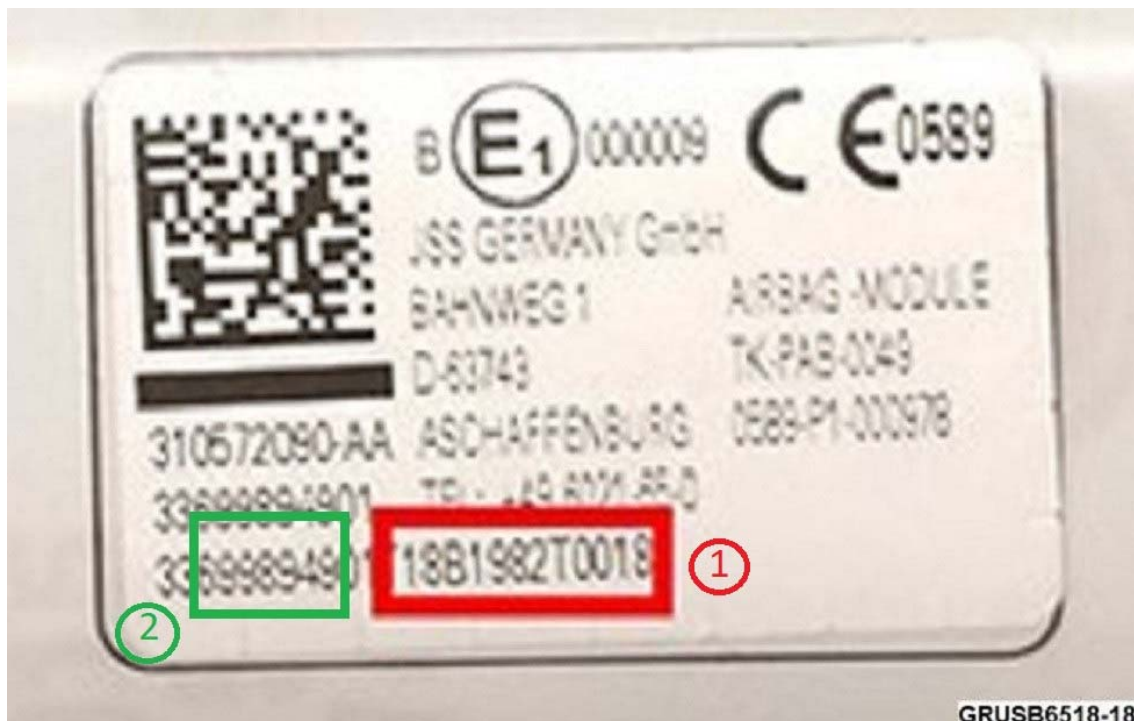
- The serial number is identified below by the red box (1).
- The last 7 digits of the part number is identified below by the green box (2).

The replacement air bag module’s serial number must be documented on the repair order so it can also be entered into the claim’s comment section.
